# Access Compliance Report

## Public Rights-of-Way (Curb Ramps)

Intersection ID: 50617	Main Street: GOLDEN_WOOD_LN	Cross Street: PADDLE_OAK_RD	Location: NW
ADA ID: 509A3E995506	Ramp Type: Perp	Initial Pass/Fail: Fail	Overall Compliance: No
		Severity Score: 12.5

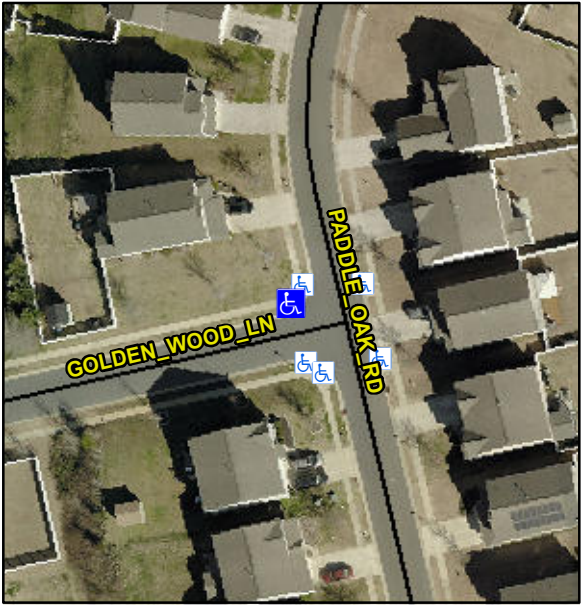
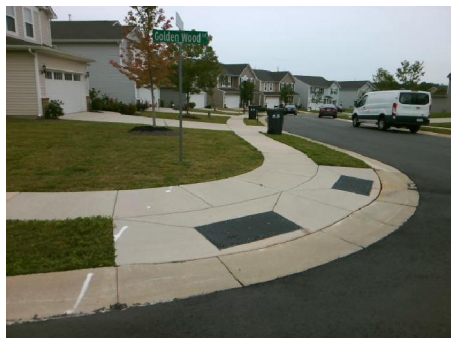
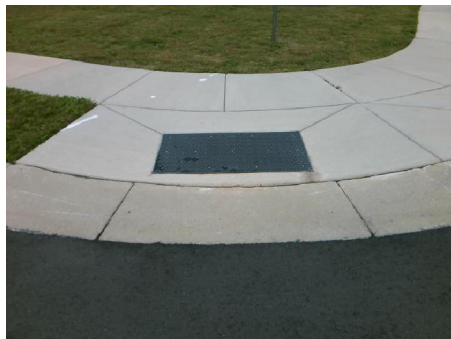
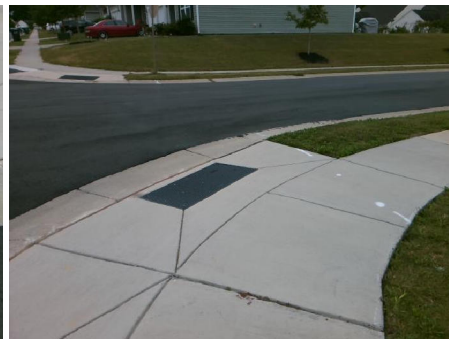
Possible Solutions:		<b>Compliance</b>	<b>Description</b>	<b>Data</b>
	Remove & Replace Entire Ramp.		N/A	Ramp Length (in)	48.0
			Yes	Ramp Width (in)	48.0
			N/A	Flare Type LT	N/A
			N/A	Flare Slope LT (%)	N/A
			N/A	Flare Traversable LT?	N/A
			N/A	Landing Length (in)	N/A
			N/A	Landing Width (in)	N/A
			N/A	Landing Slope (%)	N/A
			N/A	Landing X Slope (%)	N/A
<p>Surveyor Notes:</p> <p>N/A</p> <p>PROW/ADA:</p> <p>R304.2.2</p>			N/A	Flare Type RT	N/A
			N/A	Flare Slope RT (%)	N/A
			N/A	Flare Traversable RT?	N/A
			N/A	DWS Provided?	N/A
			N/A	DWS Contrast?	N/A
			N/A	DWS Length (in)	N/A
			N/A	DWS Full Width?	N/A
			N/A	DWS Offset (in)	N/A
			N/A	Gutter Ponding?	N/A
			N/A	Gutter Lip Ht (in)	N/A
			N/A	Painted X Walk1?	No
				X Walk 1 Direction	To S
			N/A	X Walk 1 Width (in)	N/A
				X Walk 1 Slope (%)	4.0
				X Walk 1 X Slope (%)	0.7

N/A	Ramp inside XWalk1?	N/A
				Road Slope (%)	N/A
				Road X Slope (%)	N/A
			N/A	Any Obstructions?	N/A
				Obstruction Type	
Total Cost:			\$	1850.00	
			N/A		
			Yes	Surface Condition? (G/P)	Good
