Intersection ID: N/A	Main Street: W_ARROWOOD_RD	Cross Street: S_I-77_HY	Location:	N
ADA ID: 50A41CB037A5	Ramp Type: BlendTrans2	Initial Pass/Fail: Fail	Overall Compliance: No	Severity Score: 8.75

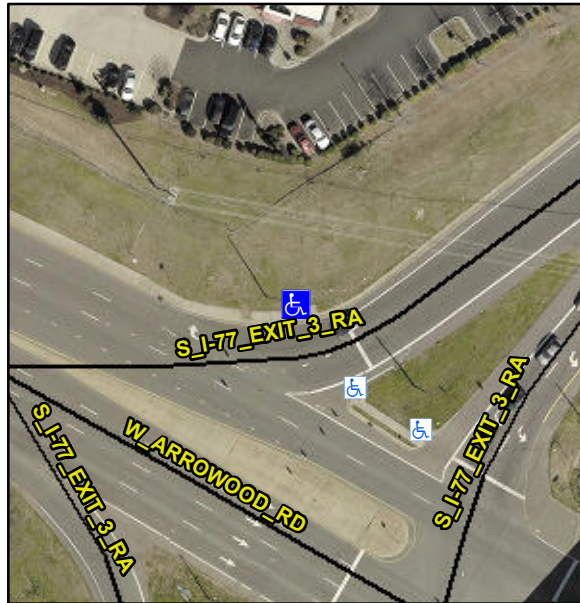
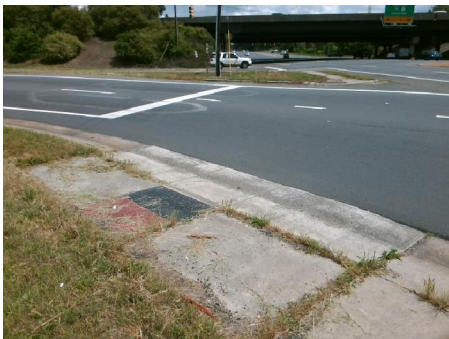
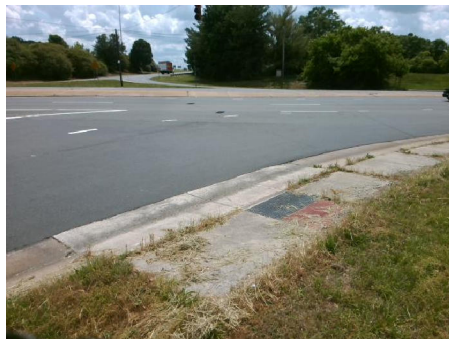
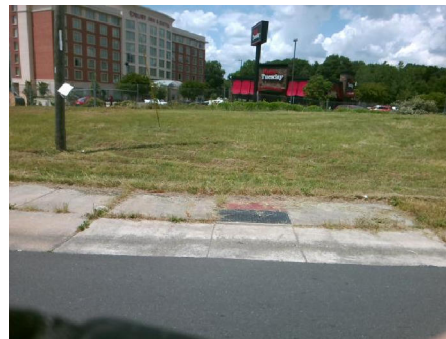
Compliance	Description	Data	Compliance	Description	Data
N/A	Ramp Length (in)	60.0	Yes	BlendTrans Slope (%)	3.0
No	Ramp Width (in)	46.0	Yes	BlendTrans XSlope (%)	0.8
N/A	Flare Type LT	N/A	N/A	Flare Type RT	N/A
N/A	Flare Slope LT (%)	N/A	N/A	Flare Slope RT (%)	N/A
N/A	Flare Traversable LT?	N/A	N/A	Flare Traversable RT?	N/A
N/A	Landing Length (in)	N/A	N/A	DWS Provided?	N/A
N/A	Landing Width (in)	N/A	N/A	DWS Contrast?	N/A
N/A	Landing Slope (%)	N/A	N/A	DWS Length (in)	N/A
N/A	Landing X Slope (%)	N/A	N/A	DWS Full Width?	N/A
N/A	Landing Curb? (Y/N)	N/A	N/A	DWS Offset (in)	N/A
N/A	Shared Landing?	N/A			
N/A	Gutter Ponding?	N/A	N/A	Gutter Slope (%)	N/A
N/A	Gutter Lip Ht (in)	N/A	N/A	Gutter X Slope (%)	N/A
N/A	Painted X Walk1?	No	N/A	Painted X Walk2?	N/A
	X Walk 1 Direction	To SE		X Walk 2 Direction	N/A
	X Walk 1 Width (in)	N/A		X Walk 2 Width (in)	N/A
	X Walk 1 Slope (%)	2.8		X Walk 2 Slope (%)	N/A
	X Walk 1 X Slope (%)	0.5		X Walk 2 X Slope (%)	N/A

N/A	Ramp inside XWalk1?	N/A	N/A	Ramp inside XWalk2?	N/A
	Road Slope (%)	0.5		Clear Space?	N/A
	Road X Slope (%)	2.8	N/A	Clear Space to XWalk (in)	N/A
N/A	Any Obstructions?	N/A	N/A	Storm Grate/Utility Hazard?	N/A
	Obstruction Type			Storm Grate/Utility Type	
		N/A			N/A
			Yes	Surface Condition? (G/P)	Good
			N/A	Curb Slope (%)	1.2

**Remove & Replace Curb Ramp With Two New Directional Ramps or Equivalent.**
