Access Compliance Report

Public Rights-of-Way

(Curb Ramps)

Intersection ID: 12783	Main Street: E_5TH_ST	Cross Street: N_ALEXANDER_ST	Location: S
ADA ID: 50A6B0D16EAF	Ramp Type: PerpDiag	Initial Pass/Fail: Fail	Overall Compliance: No
Codes/Mitigation Info/Possible Solution		Field Measurements/Component Compliance	
Severity Score: 33.75

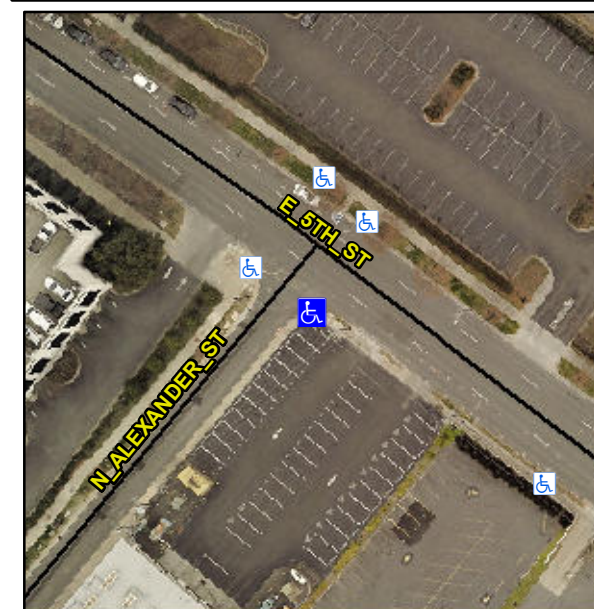
Compliance	Description	Data	Compliance	Description	Data
N/A	Ramp Length (in)	51.0	No	Ramp Slope (%)	16.3
No	Ramp Width (in)	45.0	Yes	Ramp XSlope (%)	1.3
N/A	Flare Type LT	N/A	N/A	Flare Type RT	N/A
N/A	Flare Slope LT (%)	N/A	N/A	Flare Slope RT (%)	N/A
N/A	Flare Traversable LT?	N/A	N/A	Flare Traversable RT?	N/A
N/A	Landing Length (in)	N/A	N/A	DWS Provided?	N/A
N/A	Landing Width (in)	N/A	N/A	DWS Contrast?	N/A
N/A	Landing Slope (%)	N/A	N/A	DWS Length (in)	N/A
N/A	Landing X Slope (%)	N/A	N/A	DWS Full Width?	N/A
N/A	Landing Curb? (Y/N)	N/A	N/A	DWS Offset (in)	N/A
N/A	Shared Landing?	N/A			
N/A	Gutter Ponding?	N/A	N/A	Gutter Slope (%)	N/A
N/A	Gutter Lip Ht (in)	N/A	N/A	Gutter X Slope (%)	N/A
N/A	Painted X Walk1?	No	N/A	Painted X Walk2?	No
	X Walk 1 Direction	To NE		X Walk 2 Direction	To NW
N/A	X Walk 1 Width (in)	N/A	N/A	X Walk 2 Width (in)	N/A
	X Walk 1 Slope (%)	2.9		X Walk 2 Slope (%)	0.5
	X Walk 1 X Slope (%)	0.1		X Walk 2 X Slope (%)	3.8

N/A	Ramp inside XWalk1?	N/A	N/A	Ramp inside XWalk2?	N/A
	Road Slope (%)	2.5	N/A	Clear Space?	N/A
	Road X Slope (%)	1.0	N/A	Clear Space to XWalk (in)	N/A
N/A	Any Obstructions?	N/A	N/A	Storm Grate/Utility Hazard?	N/A
	Obstruction Type			Storm Grate/Utility Type	
		N/A			N/A
			Yes	Surface Condition? (G/P)	Good

Possible Solutions:

Remove & Replace Curb Ramp With Two New Directional Ramps or Equivalent.
