# Access Compliance Report

## Public Rights-of-Way

### (Curb Ramps)

Intersection ID: 52583	Main Street: NEW_RENAISSANCE_WY	Cross Street: N/A	Location: SE
ADA ID: 50AC7E3A1C6F	Ramp Type: Perp	Initial Pass/Fail: Fail	Overall Compliance: No
			Severity Score: 13.75

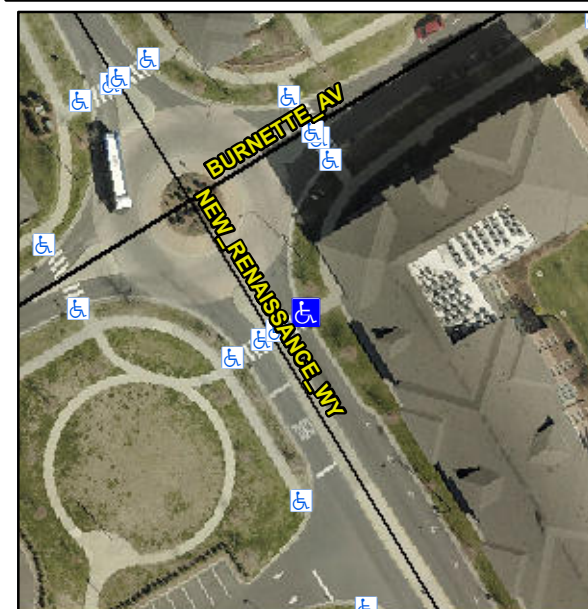
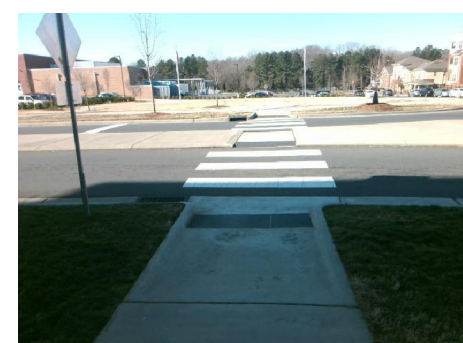
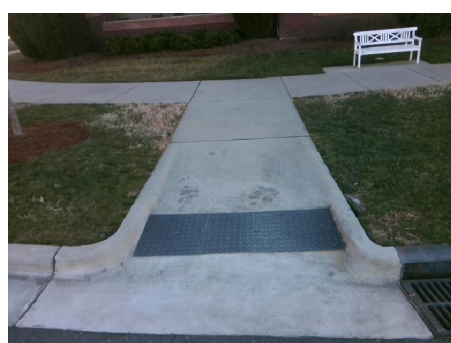
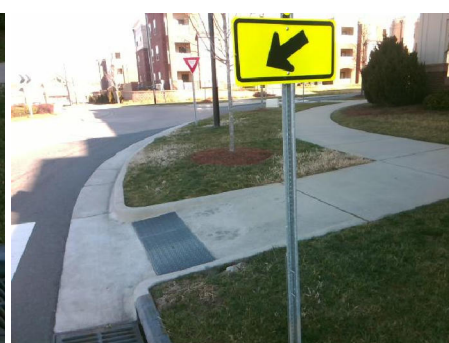
Compliance	Description	Data	Compliance	Description	Data
N/A	Ramp Length (in)	<b>99.0</b>	No	Ramp Slope (%)	<b>8.7</b>
Yes	Ramp Width (in)	<b>70.0</b>	No	Ramp XSlope (%)	<b>3.6</b>
N/A	Flare Type LT	<b>N/A</b>	N/A	Flare Type RT	<b>N/A</b>
N/A	Flare Slope LT (%)	<b>N/A</b>	N/A	Flare Slope RT (%)	<b>N/A</b>
N/A	Flare Traversable LT?	<b>N/A</b>	N/A	Flare Traversable RT?	<b>N/A</b>
N/A	Landing Length (in)	<b>N/A</b>	N/A	DWS Provided?	<b>N/A</b>
N/A	Landing Width (in)	<b>N/A</b>	N/A	DWS Contrast?	<b>N/A</b>
N/A	Landing Slope (%)	<b>N/A</b>	N/A	DWS Length (in)	<b>N/A</b>
N/A	Landing X Slope (%)	<b>N/A</b>	N/A	DWS Full Width?	<b>N/A</b>
N/A	Landing Curb? (Y/N)	<b>N/A</b>	N/A	DWS Offset (in)	<b>N/A</b>
N/A	Shared Landing?	<b>N/A</b>			
N/A	Gutter Ponding?	<b>N/A</b>	N/A	Gutter Slope (%)	<b>N/A</b>
N/A	Gutter Lip Ht (in)	<b>N/A</b>	N/A	Gutter X Slope (%)	<b>N/A</b>
N/A	Painted X Walk1?	<b>Yes</b>	N/A	Painted X Walk2?	<b>N/A</b>

X Walk 1 Direction	<b>To SW</b>		X Walk 2 Direction	<b>N/A</b>
N/A	X Walk 1 Width (in)	<b>120.0</b>	N/A	X Walk 2 Width (in)	<b>N/A</b>
	X Walk 1 Slope (%)	<b>6.2</b>		X Walk 2 Slope (%)	<b>N/A</b>
	X Walk 1 X Slope (%)	<b>1.8</b>		X Walk 2 X Slope (%)	<b>N/A</b>
N/A	Ramp inside XWalk1?	<b>Yes</b>	N/A	Ramp inside XWalk2?	<b>N/A</b>
	Road Slope (%)	<b>N/A</b>	N/A	Clear Space?	<b>N/A</b>
	Road X Slope (%)	<b>N/A</b>	N/A	Clear Space to XWalk (in)	<b>N/A</b>
N/A	Any Obstructions?	<b>N/A</b>	N/A	Storm Grate/Utility Hazard?	<b>N/A</b>
	Obstruction Type			Storm Grate/Utility Type	
		<b>N/A</b>			<b>N/A</b>
			Yes	Surface Condition? (G/P)	<b>Good</b>

**Remove & Replace Entire Ramp.**

**R304.2.2, R304.5.3**
