## Access Compliance Report Public Rights-of-Way (Curb Ramps)

Intersection ID: 49689 Main Street: ALEXANDRA\_ALLEY\_DR Cross Street: SHARON\_HILLS\_RD Location: E

ADA ID: 50B118BE81FD Ramp Type: PerpDiag Initial Pass/Fail: Fail Overall Compliance: No Severity Score: 33.75

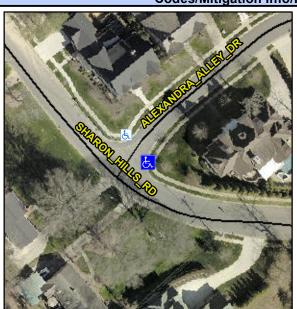
Not Found, R304.5.1, R304.5.3

Compliance Description Data Compliance Description Data Yes Ramp Slope (%) N/A Ramp Length (in) 50.5 6.0 47.5 No Ramp XSlope (%) No Ramp Width (in) 8.3 N/A N/A Flare Type LT N/A Flare Type RT N/A N/A N/A N/A Flare Slope RT (%) N/A Flare Slope LT (%) N/A Flare Traversable LT? N/A N/A Flare Traversable RT? N/A N/A N/A N/A **DWS Provided?** N/A Landing Length (in) N/A Landing Width (in) N/A N/A **DWS Contrast?** N/A N/A N/A N/A Landing Slope (%) DWS Length (in) N/A N/A Landing X Slope (%) N/A N/A DWS Full Width? N/A N/A Landing Curb? (Y/N) N/A N/A DWS Offset (in) N/A N/A N/A Shared Landing? N/A **Gutter Ponding?** N/A N/A Gutter Slope (%) N/A N/A Gutter Lip Ht (in) N/A N/A Gutter X Slope (%) N/A N/A Painted X Walk1? No N/A Painted X Walk2? No X Walk 1 Direction To NW X Walk 2 Direction To SW N/A N/A X Walk 1 Width (in) X Walk 2 Width (in) N/A X Walk 1 Slope (%) 2.7 X Walk 2 Slope (%) 2.3 X Walk 1 X Slope (%) 3.6 X Walk 2 X Slope (%) 5.2 N/A N/A N/A Ramp inside XWalk2? N/A Ramp inside XWalk1? Road Slope (%) 5.6 N/A Clear Space? N/A N/A Road X Slope (%) 0.0 Clear Space to XWalk (in) N/A N/A N/A N/A Any Obstructions? Storm Grate/Utility Hazard? N/A **Obstruction Type** Storm Grate/Utility Type N/A N/A Yes Surface Condition? (G/P) Good

Remove & Replace Curb Ramp With Two New Directional Ramps or Equivalent.
