# Access Compliance Report

## Public Rights-of-Way

Intersection ID: 14542	Main Street: DWIGHTWARE_BV	Cross Street: GLADDEN_CT	Location: NW
ADA ID: 50B3A8C251C6	Ramp Type: Directional1	Initial Pass/Fail: Fail	Overall Compliance: No
Severity Score: 12.5			
Codes/Mitigation Info/Possible Solution		Field Measurements/Component Compliance

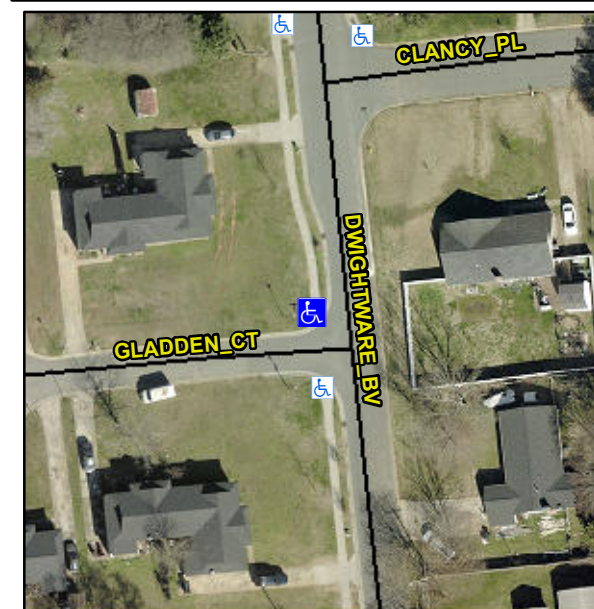
Compliance	Description	Data	Compliance	Description	Data
N/A	Ramp Length (in)	80.0	N/A	Grade Break?	N/A
Yes	Ramp Width (in)	78.0	N/A	Grade Break Slope (%)	0.0
No	Ramp Slope (%)	8.7	N/A	Grade Break XSlope (%)	0.0
Yes	Ramp XSlope (%)	1.8			
N/A	Flare Type LT	N/A	N/A	Flare Type RT	N/A
N/A	Flare Slope LT (%)	N/A	N/A	Flare Slope RT (%)	0.0
N/A	Flare Traversable LT?	N/A	N/A	Flare Traversable RT?	N/A
N/A	Landing Length (in)	0.0	N/A	DWS Provided?	N/A
N/A	Landing Width (in)	0.0	N/A	DWS Contrast?	N/A
N/A	Landing Slope (%)	0.0	N/A	DWS Length (in)	N/A
N/A	Landing X Slope (%)	0.0	N/A	DWS Full Width?	N/A
N/A	Landing Curb? (Y/N)	N/A	N/A	DWS Offset LT (in)	N/A
N/A	Shared Landing?	N/A	N/A	DWS Offset RT (in)	N/A
N/A	Gutter Ponding?	0.0	N/A	Gutter Slope (%)	N/A
N/A	Gutter Lip Ht (in)	0.0	N/A	Gutter X Slope (%)	N/A
N/A	Painted X Walk1?	No		Road Slope (%)	1.5
	X Walk 1 Direction	To S		Road X Slope (%)	5.9
	X Walk 1 Width (in)	N/A		Clear Space?	N/A

X Walk 1 Slope (%)	1.5	N/A	Clear Space to XWalk (in)	N/A
	X Walk 1 X Slope (%)	5.9	N/A	Storm Grate/Utility Hazard?	N/A
N/A	Ramp inside XWalk1?	N/A		Storm Grate/Utility Type	
N/A	Any Obstructions?	N/A			N/A
	Obstruction Type		Yes	Surface Condition? (G/P)	Good
			N/A	Curb Slope (%)	3.6

Possible Solutions:

**Remove & Replace Entire Ramp.**

**R304.2.2**
