Access Compliance Report

Public Rights-of-Way

(Curb Ramps)

Intersection ID: 11319	Main Street: ELM_ST	Cross Street: WADSWORTH_PL	Location: S
ADA ID: 50B40DF4B32C	Ramp Type: ParaDiag	Initial Pass/Fail: Fail	Overall Compliance: No
		Severity Score: 25

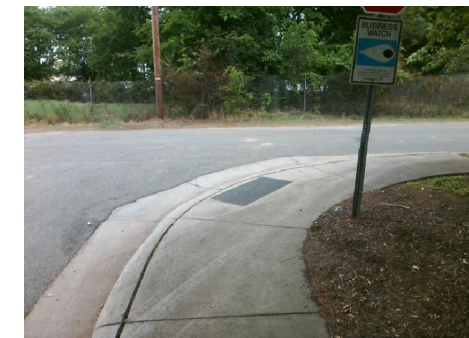
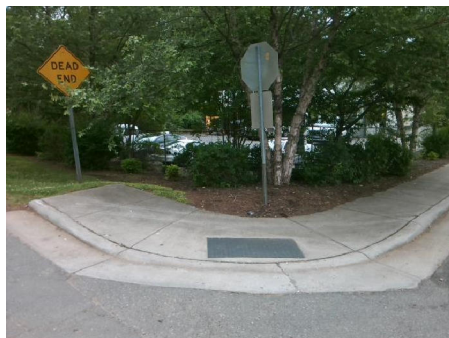
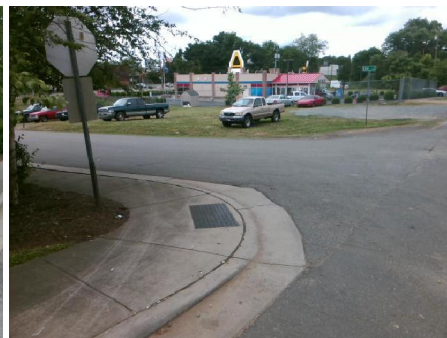
Compliance	Description	Data	Compliance	Description	Data
N/A	Ramp Length LT (in)	34.0	N/A	Ramp Length RT (in)	53.0
Yes	Ramp Width LT (in)	62.0	Yes	Ramp Width RT (in)	60.0
No	Ramp Slope LT (%)	12.8	Yes	Ramp Slope RT (%)	6.8
Yes	Ramp XSlope LT (%)	0.6	Yes	Ramp XSlope RT (%)	1.3
N/A	Landing Length (in)	N/A	N/A	DWS Provided?	N/A
N/A	Landing Width (in)	N/A	N/A	DWS Contrast?	N/A
N/A	Landing Slope (%)	N/A	N/A	DWS Length (in)	N/A
N/A	Landing X Slope (%)	N/A	N/A	DWS Full Width?	N/A
N/A	Landing Curb? (Y/N)	N/A	N/A	DWS Offset (in)	N/A
N/A	Shared Landing?	N/A			
N/A	Gutter Ponding?	N/A	N/A	Gutter Slope (%)	N/A
N/A	Gutter Lip Ht (in)	N/A	N/A	Gutter X Slope (%)	N/A
N/A	Painted X Walk1?	No	N/A	Painted X Walk2?	No
	X Walk 1 Direction	To NE		X Walk 2 Direction	To NW
N/A	X Walk 1 Width (in)	N/A	N/A	X Walk 2 Width (in)	N/A
	X Walk 1 Slope (%)	3.3		X Walk 2 Slope (%)	1.0
	X Walk 1 X Slope (%)	2.5		X Walk 2 X Slope (%)	7.3
N/A	Ramp inside XWalk1?	N/A	N/A	Ramp inside XWalk2?	N/A

Road Slope (%)	7.9	N/A	Clear Space?	N/A
	Road X Slope (%)	4.4	N/A	Clear Space to XWalk (in)	N/A
N/A	Any Obstructions?	N/A	N/A	Storm Grate/Utility Hazard?	N/A
	Obstruction Type			Storm Grate/Utility Type	
		N/A			N/A
			Yes	Surface Condition? (G/P)	Good
			N/A	Curb Slope (%)	3.0

Remove & Replace Curb Ramp With Two New Directional Ramps or Equivalent.

R304.3.2
