Access Compliance Report Public Rights-of-Way (Curb Ramps)

Intersection ID: 21442Main Street:E_ARROWOOD_RDCross Street:GRAND_METIS_DRLocation:NEADA ID: 50B4F5BCEEE2Ramp Type:ParaDiagInitial Pass/Fail:FailOverall Compliance:NoSeverity Score:25

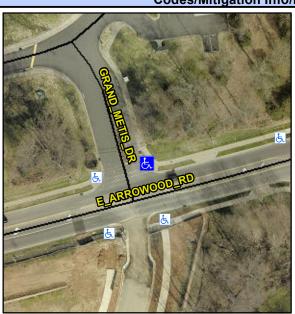
Compliance Description Data Compliance Description Data					
		Data		liance Description	Data
N/A	Ramp Length LT (in)	41.0	N/A	Ramp Length RT (in)	24.0
Yes	Ramp Width LT (in)	60.0	Yes	Ramp Width RT (in)	60.0
No	Ramp Slope LT (%)	18.3	No	Ramp Slope RT (%)	9.7
Yes	Ramp XSlope LT (%)	0.8	Yes	Ramp XSlope RT (%)	0.5
N/A	Landing Length (in)	N/A	N/A	DWS Provided?	N/A
N/A	Landing Width (in)	N/A	N/A	DWS Contrast?	N/A
N/A	Landing Slope (%)	N/A	N/A	DWS Length (in)	N/A
N/A	Landing X Slope (%)	N/A	N/A	DWS Full Width?	N/A
N/A	Landing Curb? (Y/N)	N/A	N/A	DWS Offset (in)	N/A
N/A	Shared Landing?	N/A			
N/A	Gutter Ponding?	N/A	N/A	Gutter Slope (%)	N/A
N/A	Gutter Lip Ht (in)	N/A	N/A	Gutter X Slope (%)	N/A
N/A	Painted X Walk1?	Yes	N/A	Painted X Walk2?	No
	X Walk 1 Direction	To SW		X Walk 2 Direction	To S
N/A	X Walk 1 Width (in)	53.0	N/A	X Walk 2 Width (in)	N/A
	X Walk 1 Slope (%)	6.9		X Walk 2 Slope (%)	4.3
	X Walk 1 X Slope (%)	5.8		X Walk 2 X Slope (%)	6.0

N/A	Ramp inside XWalk1?	Yes	N/A	Ramp inside XWalk2?	N/A
	Road Slope (%)	9.9	N/A	Clear Space?	N/A
	Road X Slope (%)	3.0	N/A	Clear Space to XWalk (in)	N/A
N/A	Any Obstructions?	N/A	N/A	Storm Grate/Utility Hazard?	N/A
	Obstruction Type			Storm Grate/Utility Type	
	••	N/A		,	N/A
			Yes	Surface Condition? (G/P)	Good
			N/A	Curb Slope (%)	4.0
		'	•	, , ,

Remove & Replace Curb Ramp With Two New Directional Ramps or Equivalent.

R304.3.2
