# Access Compliance Report

## Public Rights-of-Way

### (Curb Ramps)

Intersection ID: 25317	Main Street: SHADOWLAKE_DR	Cross Street: TILLERY_DR	Location:	W
ADA ID: 50BA64A88833	Ramp Type: PerpDiag	Initial Pass/Fail: Fail	Overall Compliance: No	Severity Score: 25
Codes/Mitigation Info/Possible Solution		Field Measurements/Component Compliance

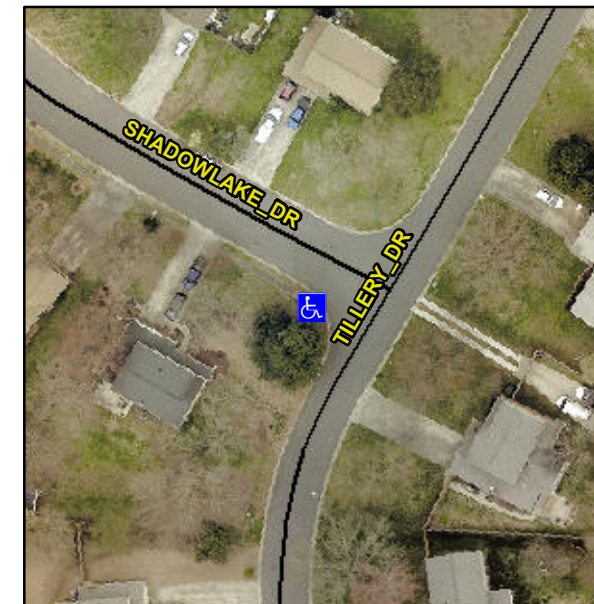
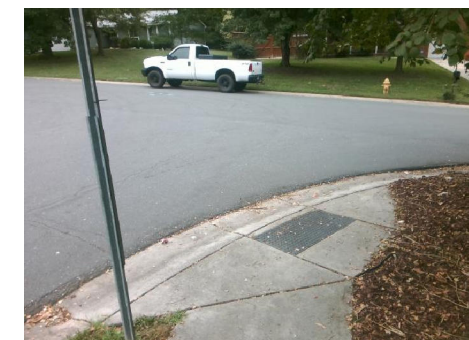
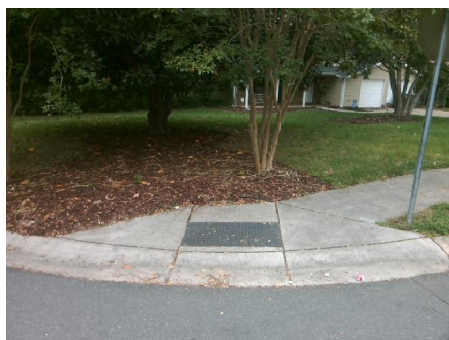
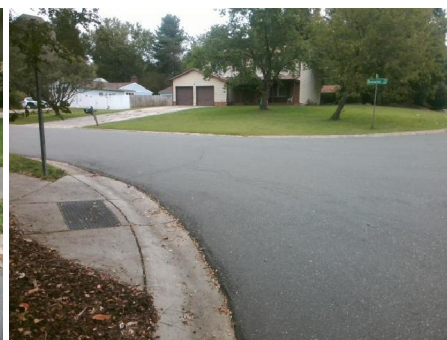
**Not Found, R304.2.2, R304.5.3**

Compliance	Description	Data	Compliance	Description	Data
N/A	Ramp Length (in)	53.0	No	Ramp Slope (%)	8.6
Yes	Ramp Width (in)	48.0	No	Ramp XSlope (%)	6.7
N/A	Flare Type LT	N/A	N/A	Flare Type RT	N/A
N/A	Flare Slope LT (%)	N/A	N/A	Flare Slope RT (%)	N/A
N/A	Flare Traversable LT?	N/A	N/A	Flare Traversable RT?	N/A
N/A	Landing Length (in)	N/A	N/A	DWS Provided?	N/A
N/A	Landing Width (in)	N/A	N/A	DWS Contrast?	N/A
N/A	Landing Slope (%)	N/A	N/A	DWS Length (in)	N/A
N/A	Landing X Slope (%)	N/A	N/A	DWS Full Width?	N/A
N/A	Landing Curb? (Y/N)	N/A	N/A	DWS Offset (in)	N/A
N/A	Shared Landing?	N/A			
N/A	Gutter Ponding?	N/A	N/A	Gutter Slope (%)	N/A
N/A	Gutter Lip Ht (in)	N/A	N/A	Gutter X Slope (%)	N/A
N/A	Painted X Walk1?	No	N/A	Painted X Walk2?	No
	X Walk 1 Direction	To SE		X Walk 2 Direction	To NE
N/A	X Walk 1 Width (in)	N/A	N/A	X Walk 2 Width (in)	N/A
	X Walk 1 Slope (%)	1.4		X Walk 2 Slope (%)	7.6
	X Walk 1 X Slope (%)	8.2		X Walk 2 X Slope (%)	0.7

N/A	Ramp inside XWalk1?	N/A	N/A	Ramp inside XWalk2?	N/A
	Road Slope (%)	3.4	N/A	Clear Space?	N/A
	Road X Slope (%)	6.6	N/A	Clear Space to XWalk (in)	N/A
N/A	Any Obstructions?	N/A	N/A	Storm Grate/Utility Hazard?	N/A
	Obstruction Type			Storm Grate/Utility Type	
		N/A			N/A
			Yes	Surface Condition? (G/P)	Good

**Remove & Replace Curb Ramp With Two New Directional Ramps or Equivalent.**
