# Access Compliance Report

## Public Rights-of-Way

### (Curb Ramps)

Intersection ID: 30252	Main Street: CENTENNIAL_DR	Cross Street: WYLAM_DILLY_CT	Location:	N
ADA ID: 50BC56DEFEF8	Ramp Type: BlendTrans1	Initial Pass/Fail: Fail	Overall Compliance: No	Severity Score: 8.75
Codes/Mitigation Info/Possible Solution		Field Measurements/Component Compliance

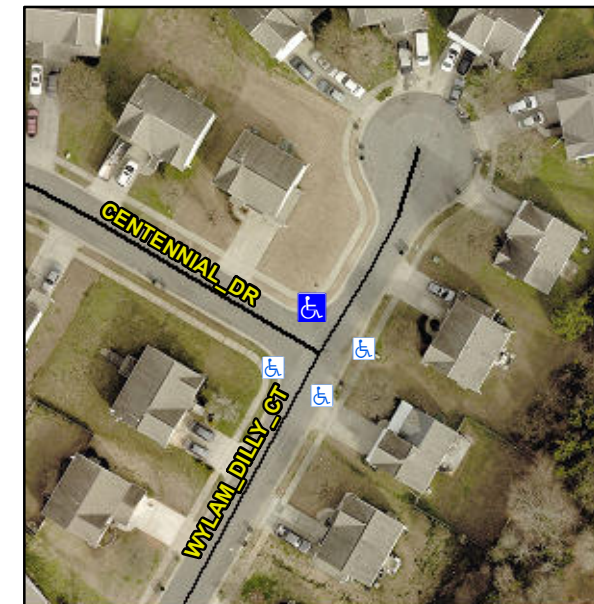
**CURB GAP 1.0**

**Not Found, R304.5.1**

Compliance	Description	Data	Compliance	Description	Data
N/A	Ramp Length (in)	48.0	Yes	BlendTrans Slope (%)	3.1
No	Ramp Width (in)	40.5	Yes	BlendTrans XSlope (%)	1.4
N/A	Flare Type LT	N/A	N/A	Flare Type RT	N/A
N/A	Flare Slope LT (%)	N/A	N/A	Flare Slope RT (%)	N/A
N/A	Flare Traversable LT?	N/A	N/A	Flare Traversable RT?	N/A
N/A	Landing Length (in)	N/A	N/A	DWS Provided?	N/A
N/A	Landing Width (in)	N/A	N/A	DWS Contrast?	N/A
N/A	Landing Slope (%)	N/A	N/A	DWS Length (in)	N/A
N/A	Landing X Slope (%)	N/A	N/A	DWS Full Width?	N/A
N/A	Landing Curb? (Y/N)	N/A	N/A	DWS Offset (in)	N/A
N/A	Shared Landing?	N/A			
N/A	Gutter Ponding?	N/A	N/A	Gutter Slope (%)	N/A
N/A	Gutter Lip Ht (in)	N/A	N/A	Gutter X Slope (%)	N/A
N/A	Painted X Walk1?	No	N/A	Painted X Walk2?	No
	X Walk 1 Direction	To SW		X Walk 2 Direction	To SE
	X Walk 1 Width (in)	N/A		X Walk 2 Width (in)	N/A
	X Walk 1 Slope (%)	1.4		X Walk 2 Slope (%)	0.8
	X Walk 1 X Slope (%)	2.9		X Walk 2 X Slope (%)	0.5

N/A	Ramp inside XWalk1?	N/A	N/A	Ramp inside XWalk2?	N/A
	Road Slope (%)	2.0		Clear Space?	N/A
	Road X Slope (%)	3.6	N/A	Clear Space to XWalk (in)	N/A
N/A	Any Obstructions?	N/A	N/A	Storm Grate/Utility Hazard?	N/A
	Obstruction Type			Storm Grate/Utility Type	
		N/A			N/A
			Yes	Surface Condition? (G/P)	Good
			No	Curb Slope (%)	14.2

Possible Solutions:

**Remove & Replace Curb Ramp With Two New Directional Ramps or Equivalent.**
