Access Compliance Report

Public Rights-of-Way

(Curb Ramps)

Intersection ID: 2769	Main Street: ASH_COVE_LN	Cross Street: BEAUVISTA_DR	Location: SW
ADA ID: 50C4DD3B54E0	Ramp Type: BlendTrans1	Initial Pass/Fail: Fail	Overall Compliance: No
			Severity Score: 33.75

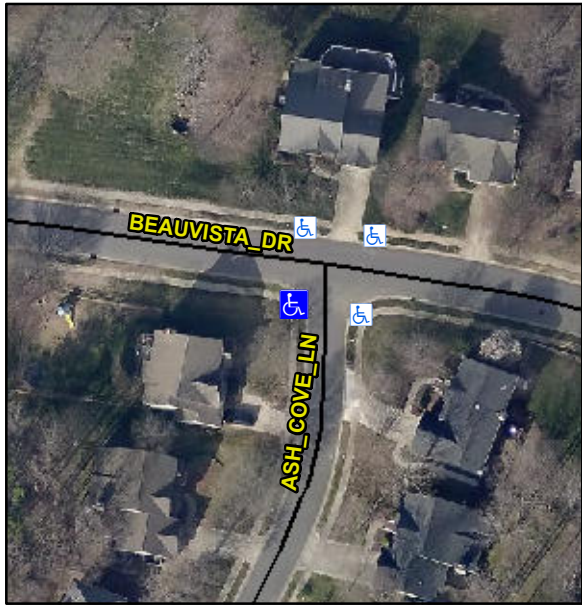
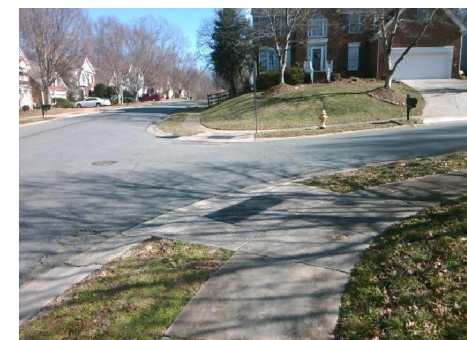
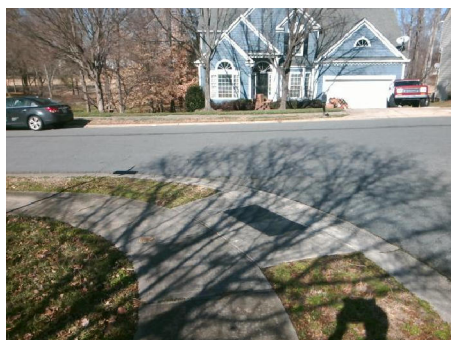
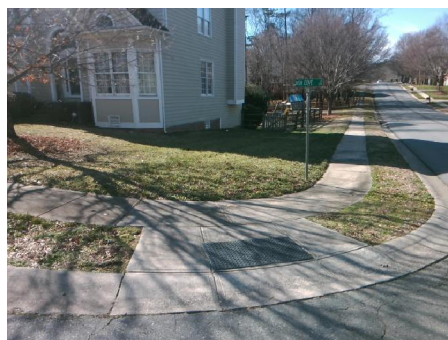
Possible Solutions:		Compliance	Description	Data	Compliance	Description	Data
	Remove & Replace Curb Ramp With Two New Directional Ramps or Equivalent.		N/A	Ramp Length (in)	48.0	Yes	BlendTrans Slope (%)	3.3
			No	Ramp Width (in)	42.0	No	BlendTrans XSlope (%)	7.1
			N/A	Flare Type LT	N/A	N/A	Flare Type RT	N/A
			N/A	Flare Slope LT (%)	N/A	N/A	Flare Slope RT (%)	N/A
			N/A	Flare Traversable LT?	N/A	N/A	Flare Traversable RT?	N/A
			N/A	Landing Length (in)	N/A	N/A	DWS Provided?	N/A
			N/A	Landing Width (in)	N/A	N/A	DWS Contrast?	N/A
			N/A	Landing Slope (%)	N/A	N/A	DWS Length (in)	N/A
			N/A	Landing X Slope (%)	N/A	N/A	DWS Full Width?	N/A
Surveyor Notes:		N/A	N/A	Landing Curb? (Y/N)	N/A	N/A	DWS Offset (in)	N/A
			N/A	Shared Landing?	N/A			
PROW/ADA:		R304.5.1, R304.5.3	N/A	Gutter Ponding?	N/A	N/A	Gutter Slope (%)	N/A

N/A	Gutter Lip Ht (in)	N/A	N/A	Gutter X Slope (%)	N/A
			N/A	Painted X Walk1?	No	N/A	Painted X Walk2?	No
				X Walk 1 Direction	To E		X Walk 2 Direction	To N
				X Walk 1 Width (in)	N/A		X Walk 2 Width (in)	N/A
				X Walk 1 Slope (%)	3.6		X Walk 2 Slope (%)	3.3
				X Walk 1 X Slope (%)	2.6		X Walk 2 X Slope (%)	4.8
			N/A	Ramp inside XWalk1?	N/A	N/A	Ramp inside XWalk2?	N/A
				Road Slope (%)	5.4		Clear Space?	N/A
				Road X Slope (%)	4.0	N/A	Clear Space to XWalk (in)	N/A
			N/A	Any Obstructions?	N/A	N/A	Storm Grate/Utility Hazard?	N/A
				Obstruction Type			Storm Grate/Utility Type	
					N/A			N/A
						Yes	Surface Condition? (G/P)	Good
						N/A	Curb Slope (%)	4.4
