Access Compliance Report

Public Rights-of-Way

(Curb Ramps)

Intersection ID: 25370	Main Street: PEVERELL_LN	Cross Street: PROVIDENCE_PLANTATION_LN	Location: E
ADA ID: 50D2ADD05176	Ramp Type: Perp	Initial Pass/Fail: Fail	Overall Compliance: No
		Severity Score: 35

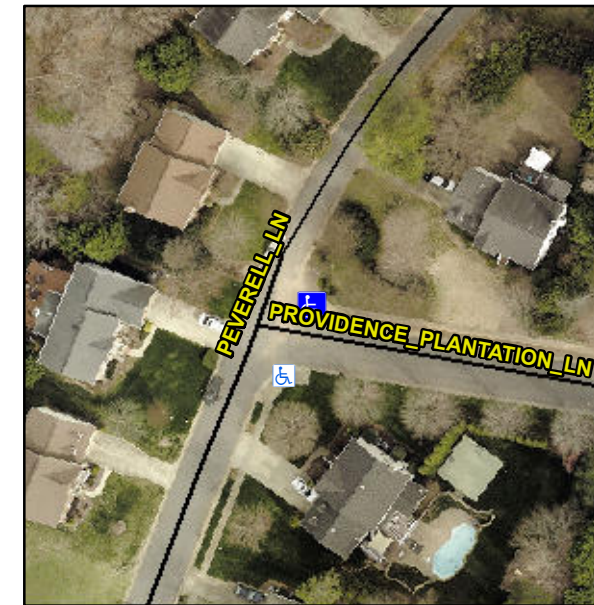
Not Found, R304.5.1

Compliance	Description	Data	Compliance	Description	Data
N/A	Ramp Length (in)	96.0	Yes	Ramp Slope (%)	5.1
No	Ramp Width (in)	29.0	Yes	Ramp XSlope (%)	0.8
N/A	Flare Type LT	N/A	N/A	Flare Type RT	N/A
N/A	Flare Slope LT (%)	N/A	N/A	Flare Slope RT (%)	N/A
N/A	Flare Traversable LT?	N/A	N/A	Flare Traversable RT?	N/A
N/A	Landing Length (in)	N/A	N/A	DWS Provided?	N/A
N/A	Landing Width (in)	N/A	N/A	DWS Contrast?	N/A
N/A	Landing Slope (%)	N/A	N/A	DWS Length (in)	N/A
N/A	Landing X Slope (%)	N/A	N/A	DWS Full Width?	N/A
N/A	Landing Curb? (Y/N)	N/A	N/A	DWS Offset (in)	N/A
N/A	Shared Landing?	N/A			
N/A	Gutter Ponding?	N/A	N/A	Gutter Slope (%)	N/A
N/A	Gutter Lip Ht (in)	N/A	N/A	Gutter X Slope (%)	N/A
N/A	Painted X Walk1?	No	N/A	Painted X Walk2?	N/A
	X Walk 1 Direction	To SW		X Walk 2 Direction	N/A
N/A	X Walk 1 Width (in)	N/A	N/A	X Walk 2 Width (in)	N/A
	X Walk 1 Slope (%)	1.8		X Walk 2 Slope (%)	N/A
	X Walk 1 X Slope (%)	1.9		X Walk 2 X Slope (%)	N/A

N/A	Ramp inside XWalk1?	N/A	N/A	Ramp inside XWalk2?	N/A
	Road Slope (%)	N/A	N/A	Clear Space?	N/A
	Road X Slope (%)	N/A	N/A	Clear Space to XWalk (in)	N/A
N/A	Any Obstructions?	N/A	N/A	Storm Grate/Utility Hazard?	N/A
	Obstruction Type			Storm Grate/Utility Type	
		N/A			N/A
			Yes	Surface Condition? (G/P)	Good

Possible Solutions:

Remove & Replace Entire Ramp.
