# Access Compliance Report

## Public Rights-of-Way

### (Curb Ramps)

| Intersection ID: 49922 | Main Street: AUSTIN_DEKOTA_DR | Cross Street: LESLIE_DR | Location: | W |

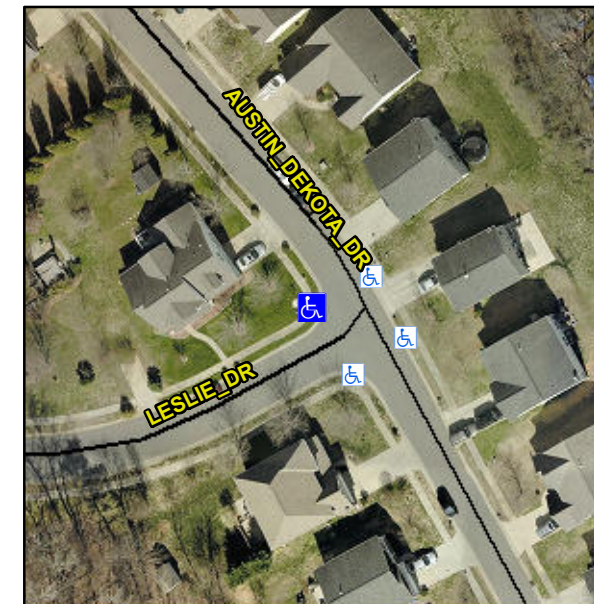
| ADA ID: 50D5A79B5CA4 | Ramp Type: BlendTrans1 | Initial Pass/Fail: Fail | Overall Compliance: No | Severity Score: 10 |

**R304.5.1, R304.5.3**

| Compliance | Description | Data | Compliance | Description | Data |
|---|---|---|---|---|---|
| No | Ramp Width (in) | 47.5 | No | BlendTrans XSlope (%) | 4.5 |

**Remove & Replace Curb Ramp With Two New Directional Ramps or Equivalent.**
