# Access Compliance Report

## Public Rights-of-Way

### (Curb Ramps)

| Intersection ID: 43475 | Main Street: LIONS_MANE_ST | Cross Street: LIONS_PAW_ST | Location: SE |

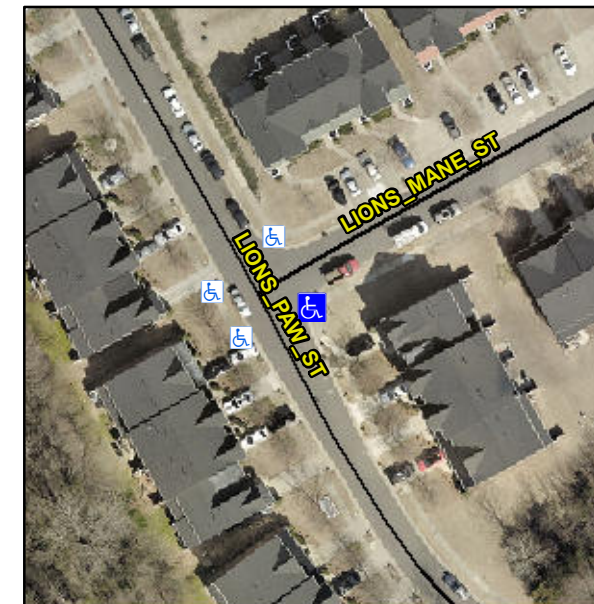
| ADA ID: 50D7FEA7EFCA | Ramp Type: PerpDiag | Initial Pass/Fail: Fail | Overall Compliance: No |

**Not Found, R304.5.1, R304.2.2, R304.5.3**

| Compliance | Description | Data | Compliance | Description | Data |
|---|---|---|---|---|---|
| N/A | Ramp Length (in) | 30.0 | No | Ramp Slope (%) | 10.6 |
| No | Ramp Width (in) | 41.0 | No | Ramp XSlope (%) | 3.2 |

**Remove & Replace Curb Ramp With Two New Directional Ramps or Equivalent.**
