Access Compliance Report

Public Rights-of-Way

(Curb Ramps)

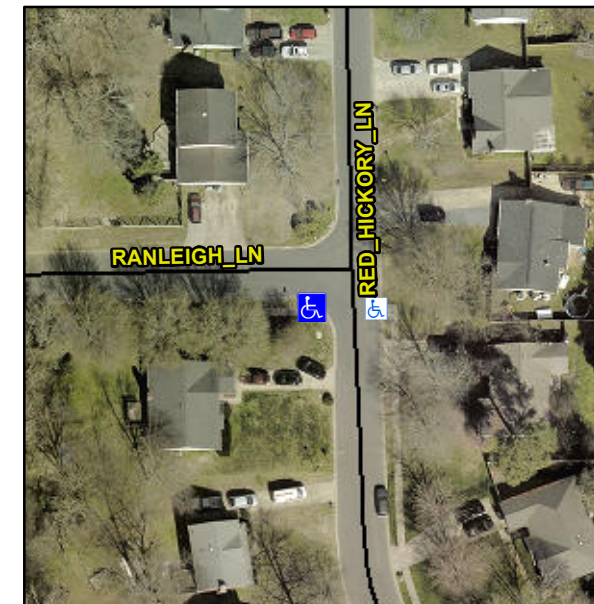
Intersection ID: 20460	Main Street: RANLEIGH_LN	Cross Street: RED_HICKORY_LN	Location: SW
ADA ID: 50D8F444ADA9	Ramp Type: Directional1	Initial Pass/Fail: Fail	Overall Compliance: No
		Severity Score: 8.75	
Codes/Mitigation Info/Possible Solution		Field Measurements/Component Compliance

Compliance	Description	Data	Compliance	Description	Data
N/A	Ramp Length (in)	66.0	N/A	Grade Break?	N/A
No	Ramp Width (in)	42.0	N/A	Grade Break Slope (%)	0.0
Yes	Ramp Slope (%)	3.8	N/A	Grade Break XSlope (%)	0.0
Yes	Ramp XSlope (%)	1.8			
N/A	Flare Type LT	N/A	N/A	Flare Type RT	N/A
N/A	Flare Slope LT (%)	N/A	N/A	Flare Slope RT (%)	0.0
N/A	Flare Traversable LT?	N/A	N/A	Flare Traversable RT?	N/A
N/A	Landing Length (in)	0.0	N/A	DWS Provided?	N/A
N/A	Landing Width (in)	0.0	N/A	DWS Contrast?	N/A
N/A	Landing Slope (%)	0.0	N/A	DWS Length (in)	N/A
N/A	Landing X Slope (%)	0.0	N/A	DWS Full Width?	N/A
N/A	Landing Curb? (Y/N)	N/A	N/A	DWS Offset LT (in)	N/A
N/A	Shared Landing?	N/A	N/A	DWS Offset RT (in)	N/A
N/A	Gutter Ponding?	0.0	N/A	Gutter Slope (%)	N/A
N/A	Gutter Lip Ht (in)	0.0	N/A	Gutter X Slope (%)	N/A
N/A	Painted X Walk1?	No		Road Slope (%)	4.7
	X Walk 1 Direction	To NE		Road X Slope (%)	2.8
	X Walk 1 Width (in)	N/A		Clear Space?	N/A

X Walk 1 Slope (%)	4.7	N/A	Clear Space to XWalk (in)	N/A
	X Walk 1 X Slope (%)	2.8	N/A	Storm Grate/Utility Hazard?	N/A
N/A	Ramp inside XWalk1?	N/A		Storm Grate/Utility Type	
N/A	Any Obstructions?	N/A			N/A
	Obstruction Type		Yes	Surface Condition? (G/P)	Good
			N/A	Curb Slope (%)	4.8

Possible Solutions:

Remove & Replace Entire Ramp.

PROW/ADA:

R304.5.1
