Access Compliance Report

Public Rights-of-Way

(Curb Ramps)

Intersection ID: 26289	Main Street: BEVINGTON_PL	Cross Street: FISHER'S_POND_DR	Location: NE
ADA ID: 50E0E76507F6	Ramp Type: PerpDiag	Initial Pass/Fail: Fail	Overall Compliance: No
Severity Score: 33.75			
Codes/Mitigation Info/Possible Solution		Field Measurements/Component Compliance

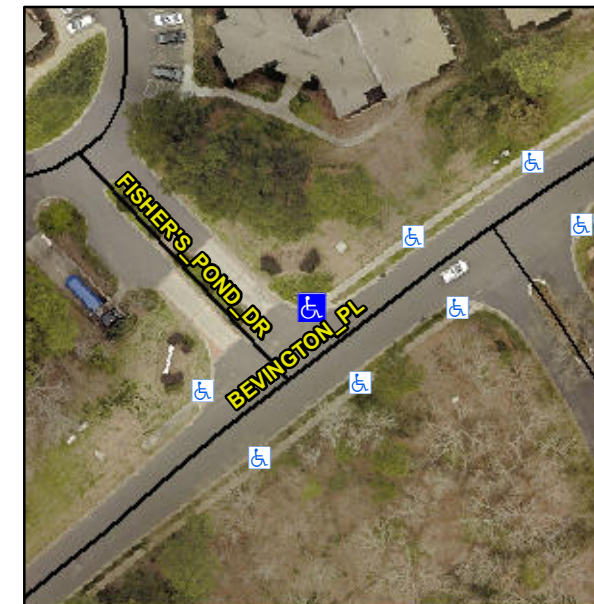
Compliance	Description	Data	Compliance	Description	Data
N/A	Ramp Length (in)	68.0	No	Ramp Slope (%)	12.6
No	Ramp Width (in)	46.5	Yes	Ramp XSlope (%)	1.6
N/A	Flare Type LT	N/A	N/A	Flare Type RT	N/A
N/A	Flare Slope LT (%)	N/A	N/A	Flare Slope RT (%)	N/A
N/A	Flare Traversable LT?	N/A	N/A	Flare Traversable RT?	N/A
N/A	Landing Length (in)	N/A	N/A	DWS Provided?	N/A
N/A	Landing Width (in)	N/A	N/A	DWS Contrast?	N/A
N/A	Landing Slope (%)	N/A	N/A	DWS Length (in)	N/A
N/A	Landing X Slope (%)	N/A	N/A	DWS Full Width?	N/A
N/A	Landing Curb? (Y/N)	N/A	N/A	DWS Offset (in)	N/A
N/A	Shared Landing?	N/A			
N/A	Gutter Ponding?	N/A	N/A	Gutter Slope (%)	N/A
N/A	Gutter Lip Ht (in)	N/A	N/A	Gutter X Slope (%)	N/A
N/A	Painted X Walk1?	No	N/A	Painted X Walk2?	No
	X Walk 1 Direction	To SW		X Walk 2 Direction	To SE
N/A	X Walk 1 Width (in)	N/A	N/A	X Walk 2 Width (in)	N/A
	X Walk 1 Slope (%)	3.9		X Walk 2 Slope (%)	2.8
	X Walk 1 X Slope (%)	4.0		X Walk 2 X Slope (%)	0.9

N/A	Ramp inside XWalk1?	N/A	N/A	Ramp inside XWalk2?	N/A
	Road Slope (%)	0.3	N/A	Clear Space?	N/A
	Road X Slope (%)	2.3	N/A	Clear Space to XWalk (in)	N/A
N/A	Any Obstructions?	N/A	N/A	Storm Grate/Utility Hazard?	N/A
	Obstruction Type			Storm Grate/Utility Type	
		N/A			N/A
		Yes		Surface Condition? (G/P)	Good

Possible Solutions:

Remove & Replace Curb Ramp With Two New Directional Ramps or Equivalent.

R304.5.1, R304.2.2
