Access Compliance Report

Public Rights-of-Way

(Curb Ramps)

Intersection ID: 27538	Main Street: ALTON_FARM_LN	Cross Street: CHARLOTTE_VIEW_DR	Location: NE
ADA ID: 50EDFA622E8E	Ramp Type: PerpDiag	Initial Pass/Fail: Fail	Overall Compliance: No
Severity Score: 12.5			
Codes/Mitigation Info/Possible Solution		Field Measurements/Component Compliance

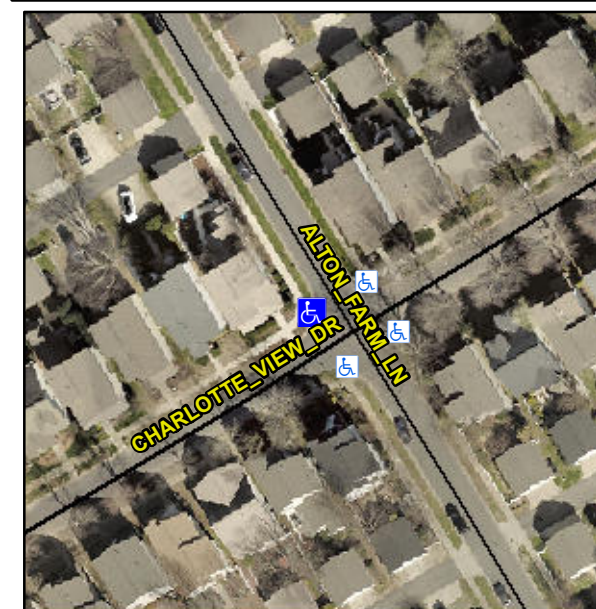
Not Found, R304.2.2

Compliance	Description	Data	Compliance	Description	Data
N/A	Ramp Length (in)	60.0	No	Ramp Slope (%)	9.9
Yes	Ramp Width (in)	48.0	Yes	Ramp XSlope (%)	0.8
N/A	Flare Type LT	N/A	N/A	Flare Type RT	N/A
N/A	Flare Slope LT (%)	N/A	N/A	Flare Slope RT (%)	N/A
N/A	Flare Traversable LT?	N/A	N/A	Flare Traversable RT?	N/A
N/A	Landing Length (in)	N/A	N/A	DWS Provided?	N/A
N/A	Landing Width (in)	N/A	N/A	DWS Contrast?	N/A
N/A	Landing Slope (%)	N/A	N/A	DWS Length (in)	N/A
N/A	Landing X Slope (%)	N/A	N/A	DWS Full Width?	N/A
N/A	Landing Curb? (Y/N)	N/A	N/A	DWS Offset (in)	N/A
N/A	Shared Landing?	N/A			
N/A	Gutter Ponding?	N/A	N/A	Gutter Slope (%)	N/A
N/A	Gutter Lip Ht (in)	N/A	N/A	Gutter X Slope (%)	N/A
N/A	Painted X Walk1?	No	N/A	Painted X Walk2?	No
	X Walk 1 Direction	To S		X Walk 2 Direction	To NE
N/A	X Walk 1 Width (in)	N/A	N/A	X Walk 2 Width (in)	N/A
	X Walk 1 Slope (%)	2.0		X Walk 2 Slope (%)	1.4
	X Walk 1 X Slope (%)	1.2		X Walk 2 X Slope (%)	2.4

N/A	Ramp inside XWalk1?	N/A	N/A	Ramp inside XWalk2?	N/A
	Road Slope (%)	2.3	N/A	Clear Space?	N/A
	Road X Slope (%)	2.1	N/A	Clear Space to XWalk (in)	N/A
N/A	Any Obstructions?	N/A	N/A	Storm Grate/Utility Hazard?	N/A
	Obstruction Type			Storm Grate/Utility Type	
		N/A			N/A
		Yes		Surface Condition? (G/P)	Good

Remove & Replace Curb Ramp With Two New Directional Ramps or Equivalent.

Total Cost: \$ 3200.00
