Access Compliance Report

Public Rights-of-Way

(Curb Ramps)

Intersection ID: 45096	Main Street: E_9TH_ST	Cross Street: N_DAVIDSON_ST	Location: W
ADA ID: 50F2B2E1E5F2	Ramp Type: Directional1	Initial Pass/Fail: Fail	Overall Compliance: No
		Severity Score: 25

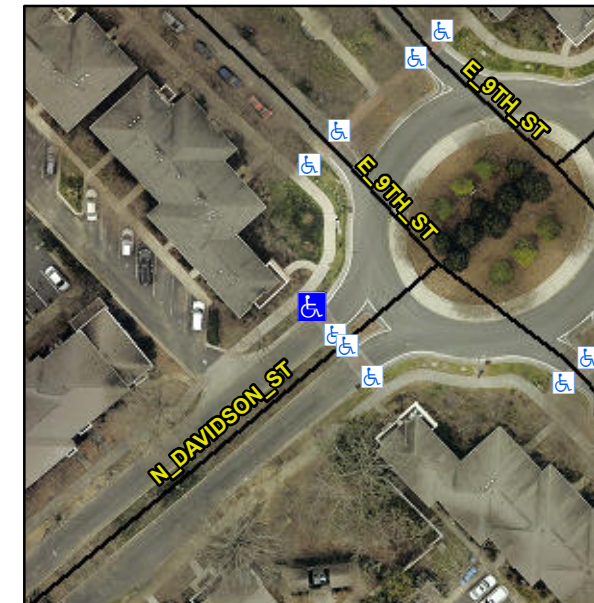
LNDG LIP 0.5"

Compliance	Description	Data	Compliance	Description	Data
N/A	Ramp Length (in)	71.0	N/A	Grade Break?	N/A
Yes	Ramp Width (in)	70.0	N/A	Grade Break Slope (%)	0.0
No	Ramp Slope (%)	10.2	N/A	Grade Break XSlope (%)	0.0
No	Ramp XSlope (%)	5.1			
N/A	Flare Type LT	N/A	N/A	Flare Type RT	N/A
N/A	Flare Slope LT (%)	N/A	N/A	Flare Slope RT (%)	0.0
N/A	Flare Traversable LT?	N/A	N/A	Flare Traversable RT?	N/A
N/A	Landing Length (in)	0.0	N/A	DWS Provided?	N/A
N/A	Landing Width (in)	0.0	N/A	DWS Contrast?	N/A
N/A	Landing Slope (%)	0.0	N/A	DWS Length (in)	N/A
N/A	Landing X Slope (%)	0.0	N/A	DWS Full Width?	N/A
N/A	Landing Curb? (Y/N)	N/A	N/A	DWS Offset LT (in)	N/A
N/A	Shared Landing?	N/A	N/A	DWS Offset RT (in)	N/A
N/A	Gutter Ponding?	0.0	N/A	Gutter Slope (%)	N/A
N/A	Gutter Lip Ht (in)	0.0	N/A	Gutter X Slope (%)	N/A
N/A	Painted X Walk1?	Yes		Road Slope (%)	3.2
	X Walk 1 Direction	To SE		Road X Slope (%)	8.8
	X Walk 1 Width (in)	82.0		Clear Space?	N/A

X Walk 1 Slope (%)	3.2	N/A	Clear Space to XWalk (in)	N/A
	X Walk 1 X Slope (%)	8.8	N/A	Storm Grate/Utility Hazard?	N/A
N/A	Ramp inside XWalk1?	Yes		Storm Grate/Utility Type	
N/A	Any Obstructions?	N/A			N/A
	Obstruction Type		Yes	Surface Condition? (G/P)	Good
			N/A	Curb Slope (%)	10.4

Possible Solutions:

Remove & Replace Entire Ramp.
