Access Compliance Report

Public Rights-of-Way

(Curb Ramps)

Intersection ID: 18172	Main Street: FOREST_GREEN_DR	Cross Street: LITTLE MOSER_LN	Location: NW
ADA ID: 50F847BAE592	Ramp Type: PerpDiag	Initial Pass/Fail: Fail	Overall Compliance: No
Severity Score: 22.5			
Codes/Mitigation Info/Possible Solution		Field Measurements/Component Compliance

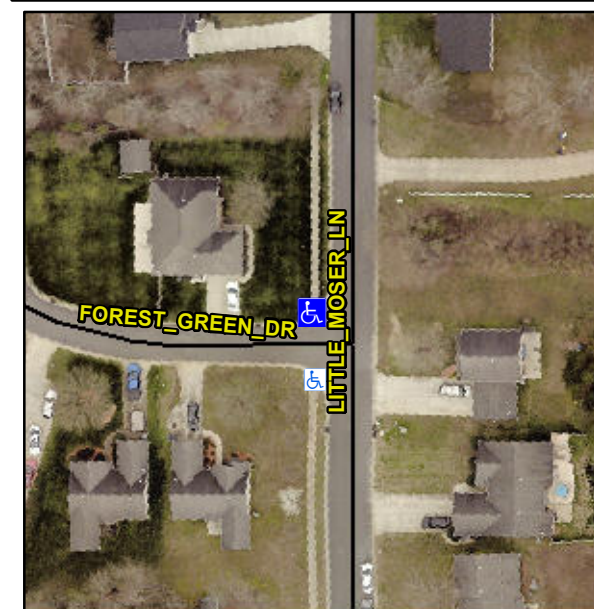
Not Found, R304.5.1, R304.2.2, R304.5.3

Compliance	Description	Data	Compliance	Description	Data
N/A	Ramp Length (in)	45.0	No	Ramp Slope (%)	10.3
No	Ramp Width (in)	36.0	No	Ramp XSlope (%)	4.4
N/A	Flare Type LT	N/A	N/A	Flare Type RT	N/A
N/A	Flare Slope LT (%)	N/A	N/A	Flare Slope RT (%)	N/A
N/A	Flare Traversable LT?	N/A	N/A	Flare Traversable RT?	N/A
N/A	Landing Length (in)	N/A	N/A	DWS Provided?	N/A
N/A	Landing Width (in)	N/A	N/A	DWS Contrast?	N/A
N/A	Landing Slope (%)	N/A	N/A	DWS Length (in)	N/A
N/A	Landing X Slope (%)	N/A	N/A	DWS Full Width?	N/A
N/A	Landing Curb? (Y/N)	N/A	N/A	DWS Offset (in)	N/A
N/A	Shared Landing?	N/A			
N/A	Gutter Ponding?	N/A	N/A	Gutter Slope (%)	N/A
N/A	Gutter Lip Ht (in)	N/A	N/A	Gutter X Slope (%)	N/A
N/A	Painted X Walk1?	No	N/A	Painted X Walk2?	No
	X Walk 1 Direction	To SW		X Walk 2 Direction	To E
N/A	X Walk 1 Width (in)	N/A	N/A	X Walk 2 Width (in)	N/A
	X Walk 1 Slope (%)	1.5		X Walk 2 Slope (%)	3.5
	X Walk 1 X Slope (%)	3.2		X Walk 2 X Slope (%)	1.6

N/A	Ramp inside XWalk1?	N/A	N/A	Ramp inside XWalk2?	N/A
	Road Slope (%)	3.7	N/A	Clear Space?	N/A
	Road X Slope (%)	1.0	N/A	Clear Space to XWalk (in)	N/A
N/A	Any Obstructions?	N/A	N/A	Storm Grate/Utility Hazard?	N/A
	Obstruction Type			Storm Grate/Utility Type	
		N/A			N/A
			Yes	Surface Condition? (G/P)	Good

Possible Solutions:

Remove & Replace Curb Ramp With Two New Directional Ramps or Equivalent.
