Access Compliance Report

Public Rights-of-Way

(Curb Ramps)

Intersection ID: 10734	Main Street: DUNLOE_ST	Cross Street: SYLVANIA_AV	Location: E
ADA ID: 5106F529F85C	Ramp Type: Perp	Initial Pass/Fail: Fail	Overall Compliance: No
Severity Score: 1.25			
Codes/Mitigation Info/Possible Solution		Field Measurements/Component Compliance

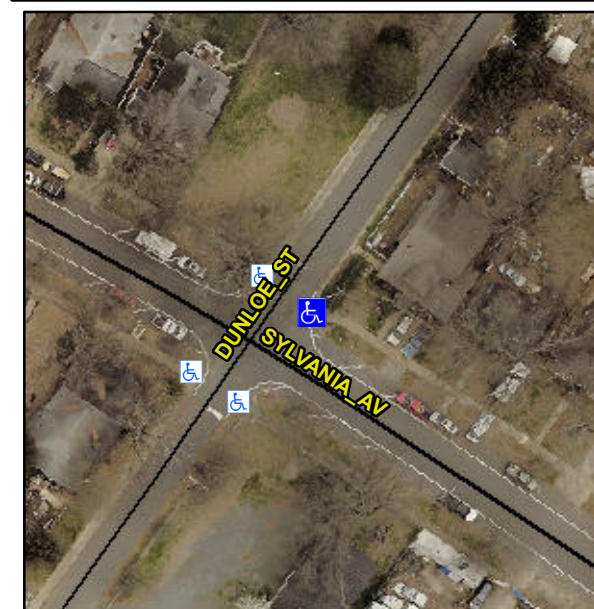
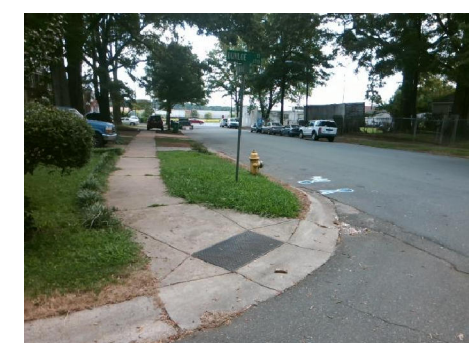
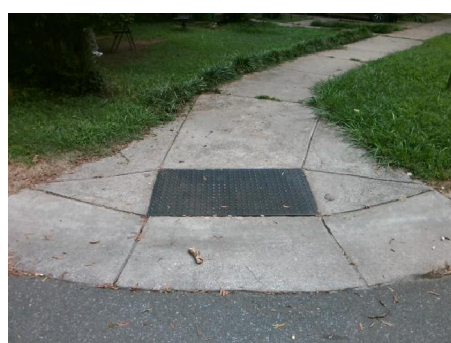
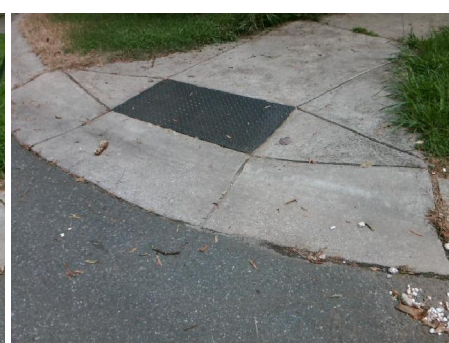
Not Found, R304.5.3

Compliance	Description	Data	Compliance	Description	Data
N/A	Ramp Length (in)	25.0	Yes	Ramp Slope (%)	6.7
Yes	Ramp Width (in)	48.0	No	Ramp XSlope (%)	2.9
N/A	Flare Type LT	N/A	N/A	Flare Type RT	N/A
N/A	Flare Slope LT (%)	N/A	N/A	Flare Slope RT (%)	N/A
N/A	Flare Traversable LT?	N/A	N/A	Flare Traversable RT?	N/A
N/A	Landing Length (in)	N/A	N/A	DWS Provided?	N/A
N/A	Landing Width (in)	N/A	N/A	DWS Contrast?	N/A
N/A	Landing Slope (%)	N/A	N/A	DWS Length (in)	N/A
N/A	Landing X Slope (%)	N/A	N/A	DWS Full Width?	N/A
N/A	Landing Curb? (Y/N)	N/A	N/A	DWS Offset (in)	N/A
N/A	Shared Landing?	N/A			
N/A	Gutter Ponding?	N/A	N/A	Gutter Slope (%)	N/A
N/A	Gutter Lip Ht (in)	1.5	N/A	Gutter X Slope (%)	N/A
N/A	Painted X Walk1?	No	N/A	Painted X Walk2?	N/A
	X Walk 1 Direction	To NW		X Walk 2 Direction	N/A
N/A	X Walk 1 Width (in)	N/A	N/A	X Walk 2 Width (in)	N/A
	X Walk 1 Slope (%)	4.5		X Walk 2 Slope (%)	N/A
	X Walk 1 X Slope (%)	3.0		X Walk 2 X Slope (%)	N/A

N/A	Ramp inside XWalk1?	N/A	N/A	Ramp inside XWalk2?	N/A
	Road Slope (%)	N/A	N/A	Clear Space?	N/A
	Road X Slope (%)	N/A	N/A	Clear Space to XWalk (in)	N/A
N/A	Any Obstructions?	N/A	N/A	Storm Grate/Utility Hazard?	N/A
	Obstruction Type			Storm Grate/Utility Type	
		N/A			N/A
			Yes	Surface Condition? (G/P)	Good

Remove & Replace Entire Ramp.
