# Access Compliance Report

## Public Rights-of-Way

### (Curb Ramps)

| Intersection ID: 10599 | Main Street: BARRINGTON_DR | Cross Street: BELLE_PLAINE_DR | Location: SW |

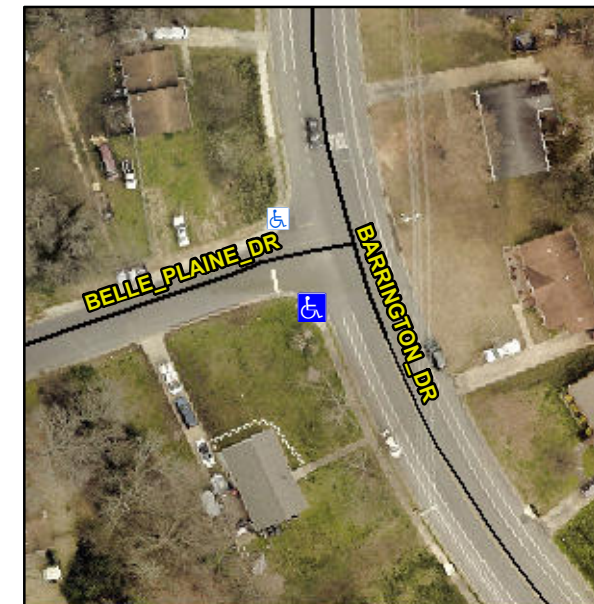
| ADA ID: 51102036AE35 | Ramp Type: Perp | Initial Pass/Fail: Fail | Overall Compliance: No |
| Severity Score: 13.75 | | | |

**Not Found, R304.2.2, R304.5.3**

| Compliance | Description | Data | Compliance | Description | Data |
|---|---|---|---|---|---|
| N/A | Ramp Length (in) | 28.0 | No | Ramp Slope (%) | 9.0 |
| Yes | Ramp Width (in) | 48.0 | No | Ramp XSlope (%) | 4.9 |

**Remove & Replace Entire Ramp.**

Total Cost: \$ 1850.00
