# Access Compliance Report

## Public Rights-of-Way

### (Curb Ramps)

Intersection ID: 3814	Main Street: NETTLE_DR	Cross Street: PASTER_N_CT	Location: SE
ADA ID: 511278DFB2E9	Ramp Type: Perp	Initial Pass/Fail: Fail	Overall Compliance: No
Severity Score: 13.75			
Codes/Mitigation Info/Possible Solution		Field Measurements/Component Compliance

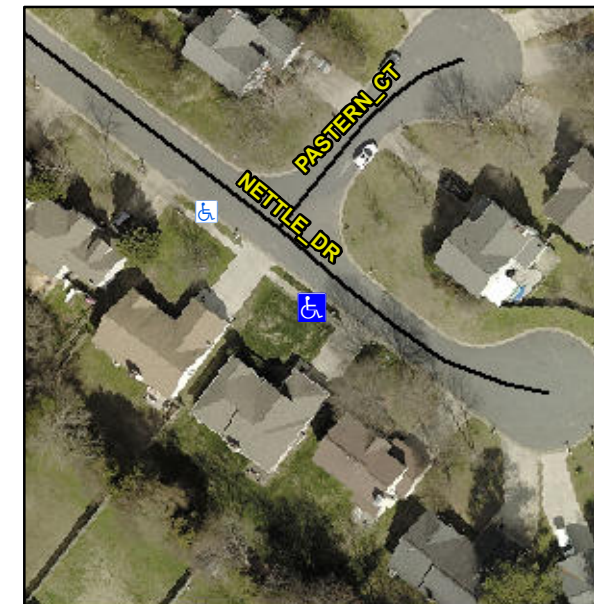
**Not Found, R304.2.2**

Compliance	Description	Data	Compliance	Description	Data
N/A	Ramp Length (in)	45.5	No	Ramp Slope (%)	8.4
Yes	Ramp Width (in)	48.0	Yes	Ramp XSlope (%)	2.3
N/A	Flare Type LT	N/A	N/A	Flare Type RT	N/A
N/A	Flare Slope LT (%)	N/A	N/A	Flare Slope RT (%)	N/A
N/A	Flare Traversable LT?	N/A	N/A	Flare Traversable RT?	N/A
N/A	Landing Length (in)	N/A	N/A	DWS Provided?	N/A
N/A	Landing Width (in)	N/A	N/A	DWS Contrast?	N/A
N/A	Landing Slope (%)	N/A	N/A	DWS Length (in)	N/A
N/A	Landing X Slope (%)	N/A	N/A	DWS Full Width?	N/A
N/A	Landing Curb? (Y/N)	N/A	N/A	DWS Offset (in)	N/A
N/A	Shared Landing?	N/A			
N/A	Gutter Ponding?	N/A	N/A	Gutter Slope (%)	N/A
N/A	Gutter Lip Ht (in)	N/A	N/A	Gutter X Slope (%)	N/A
N/A	Painted X Walk1?	No	N/A	Painted X Walk2?	N/A
	X Walk 1 Direction	To NE		X Walk 2 Direction	N/A
N/A	X Walk 1 Width (in)	N/A	N/A	X Walk 2 Width (in)	N/A
	X Walk 1 Slope (%)	5.2		X Walk 2 Slope (%)	N/A
	X Walk 1 X Slope (%)	3.6		X Walk 2 X Slope (%)	N/A

N/A	Ramp inside XWalk1?	N/A	N/A	Ramp inside XWalk2?	N/A
	Road Slope (%)	3.6	N/A	Clear Space?	N/A
	Road X Slope (%)	5.2	N/A	Clear Space to XWalk (in)	N/A
N/A	Any Obstructions?	N/A	N/A	Storm Grate/Utility Hazard?	N/A
	Obstruction Type			Storm Grate/Utility Type	
		N/A			N/A
			Yes	Surface Condition? (G/P)	Good

**Remove & Replace Entire Ramp.**
