Access Compliance Report

Public Rights-of-Way

(Curb Ramps)

Intersection ID: 49359	Main Street: PARK_SOUTH_DR	Cross Street: GARDEN_PATH_LN	Location:	S
ADA ID: 51188CAE12F3	Ramp Type: PerpDiag	Initial Pass/Fail: Pass	Overall Compliance: No	Severity Score: 15
Codes/Mitigation Info/Possible Solution		Field Measurements/Component Compliance

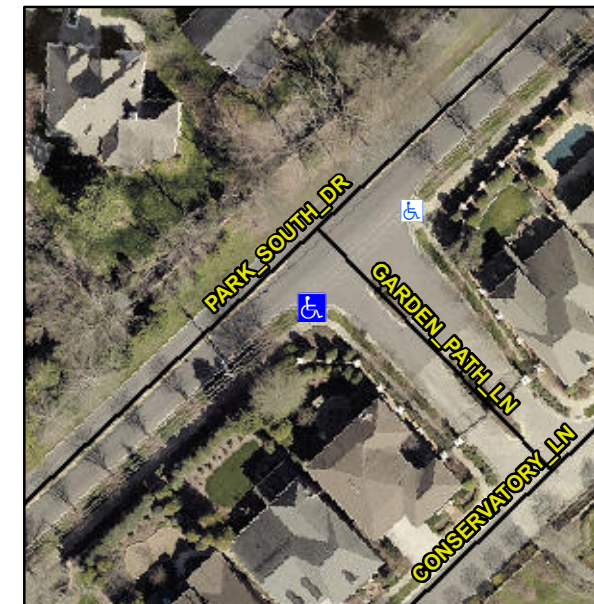
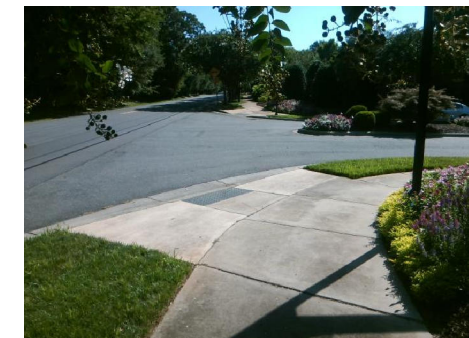
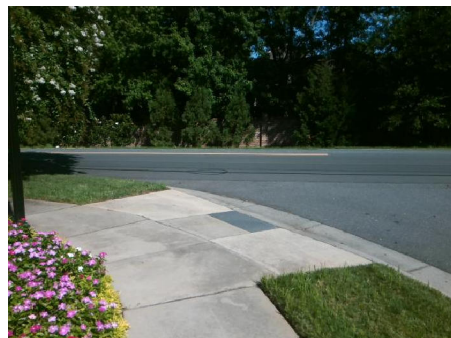
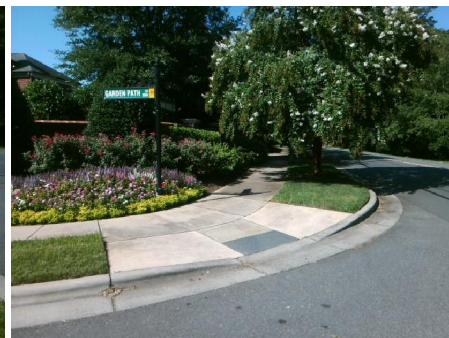
Not Found, R304.2.1, R304.2.2-Perp, R304.3.2-Para, R304.5.3, R304.5.4

Compliance	Description	Data	Compliance	Description	Data
N/A	Ramp Length (in)	118.0	Yes	Ramp Slope (%)	5.7
Yes	Ramp Width (in)	48.0	Yes	Ramp XSlope (%)	1.1
N/A	Flare Type LT	Sloped	N/A	Flare Type RT	N/A
N/A	Flare Slope LT (%)	6.1	Yes	Flare Slope RT (%)	5.0
N/A	Flare Traversable LT?	Yes	N/A	Flare Traversable RT?	Yes
No	Landing Length (in)	N/A	Yes	DWS Provided?	Yes
No	Landing Width (in)	N/A	Yes	DWS Contrast?	Yes
No	Landing Slope (%)	N/A	Yes	DWS Length (in)	24.0
No	Landing X Slope (%)	N/A	Yes	DWS Full Width?	Yes
N/A	Landing Curb? (Y/N)	No	Yes	DWS Offset (in)	1.0
N/A	Shared Landing?	N/A			
Yes	Gutter Ponding?	No	No	Gutter Slope (%)	5.8
Yes	Gutter Lip Ht (in)	0.0	Yes	Gutter X Slope (%)	0.2
N/A	Painted X Walk1?	No	N/A	Painted X Walk2?	No
	X Walk 1 Direction	To NE		X Walk 2 Direction	To N
N/A	X Walk 1 Width (in)	N/A	N/A	X Walk 2 Width (in)	N/A
	X Walk 1 Slope (%)	3.1		X Walk 2 Slope (%)	4.9
	X Walk 1 X Slope (%)	2.4		X Walk 2 X Slope (%)	2.5

N/A	Ramp inside XWalk1?	N/A	N/A	Ramp inside XWalk2?	N/A
	Road Slope (%)	0.6	N/A	Clear Space?	Yes
	Road X Slope (%)	5.1	N/A	Clear Space to XWalk (in)	N/A
Yes	Any Obstructions?	No	Yes	Storm Grate/Utility Hazard?	No
	Obstruction Type			Storm Grate/Utility Type	
		N/A			N/A
			Yes	Surface Condition? (G/P)	Good

Possible Solutions:

Remove & Replace Curb Ramp With Two New Directional Ramps or Equivalent. Remove & Replace Gutter.
