Access Compliance Report Public Rights-of-Way (Curb Ramps)

Intersection ID: 48263 Main Street: EAST ARBORS DR **Cross Street: SENATOR ROYALL DR** Location: W **ADA ID: 511DDFC8C678** Ramp Type: PerpDiag Initial Pass/Fail: Fail **Overall Compliance: No Severity Score:** 22.5

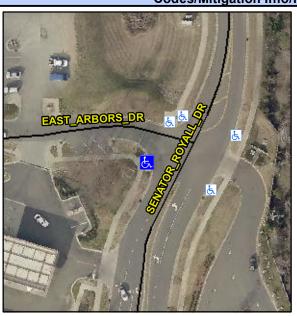
Field Measurements/Component Compliance						
	Compliance Description		Data	Comp	liance Description	Data
	N/A	Ramp Length (in)	96.0	No	Ramp Slope (%)	8.9
	No	Ramp Width (in)	46.0	No	Ramp XSlope (%)	3.5
	N/A	Flare Type LT	N/A	N/A	Flare Type RT	N/A
	N/A	Flare Slope LT (%)	N/A	N/A	Flare Slope RT (%)	N/A
	N/A	Flare Traversable LT?	N/A	N/A	Flare Traversable RT?	N/A
	N/A	Landing Length (in)	N/A	N/A	DWS Provided?	N/A
	N/A	Landing Width (in)	N/A	N/A	DWS Contrast?	N/A
	N/A	Landing Slope (%)	N/A	N/A	DWS Length (in)	N/A
	N/A	Landing X Slope (%)	N/A	N/A	DWS Full Width?	N/A
	N/A	Landing Curb? (Y/N)	N/A	N/A	DWS Offset (in)	N/A
	N/A	Shared Landing?	N/A			
	N/A	Gutter Ponding?	N/A	N/A	Gutter Slope (%)	N/A
	N/A	Gutter Lip Ht (in)	N/A	N/A	Gutter X Slope (%)	N/A
	N/A	Painted X Walk1?	No	N/A	Painted X Walk2?	No
		X Walk 1 Direction	To NE		X Walk 2 Direction	To SE
	N/A	X Walk 1 Width (in)	N/A	N/A	X Walk 2 Width (in)	N/A
		X Walk 1 Slope (%)	1.6		X Walk 2 Slope (%)	8.3

X Walk 1 X Slope (%)	8.6		X Walk 2 X Slope (%)	1.4
	N/A	Ramp inside XWalk1?	N/A	N/A	Ramp inside XWalk2?	N/A
		Road Slope (%)	4.4	N/A	Clear Space?	N/A
		Road X Slope (%)	6.3	N/A	Clear Space to XWalk (in)	N/A
	N/A	Any Obstructions?	N/A	N/A	Storm Grate/Utility Hazard?	N/A
		Obstruction Type			Storm Grate/Utility Type	
			N/A			N/A
				Yes	Surface Condition? (G/P)	Good
11	sales of	2 2 2 10 20

Possible Solutions: Remove & Replace Curb Ramp With **Two New Directional Ramps or** Equivalent. Surveyor Notes: N/A PROW/ADA: R304.5.1, R304.2.2, R304.5.3

Total Cost: 3200.00
