Access Compliance Report Public Rights-of-Way (Curb Ramps)

Intersection ID: 16682	Main Street: MARSH_RD	Cross Street: LEASIDE_LN	Location: N
ADA ID: 512D5E405E69	Ramp Type: PerpDiag	Initial Pass/Fail: Fail	Overall Compliance: No Severity Score: 37.5

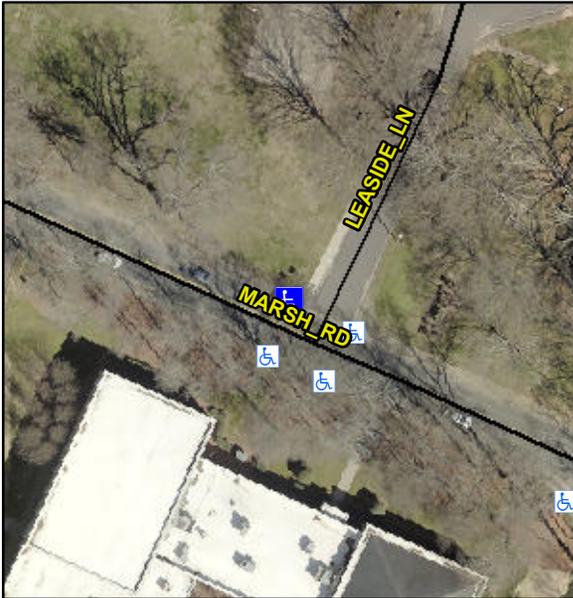
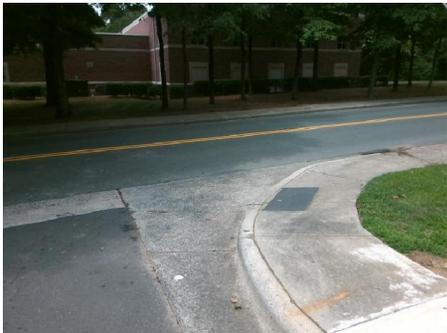
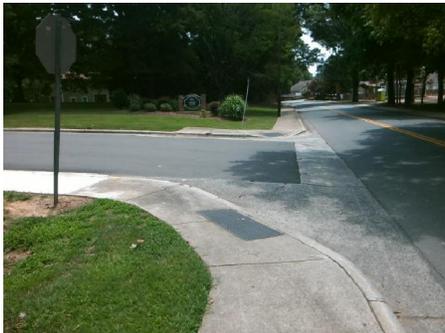
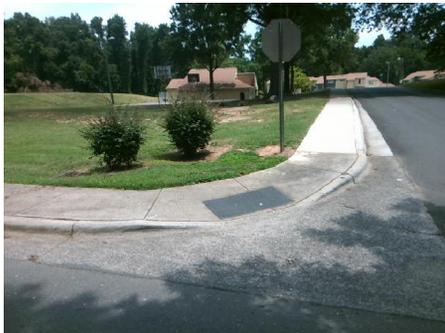
PROW/ADA:
Not Found, R304.2.2, R304.5.3

Compliance	Description	Data	Compliance	Description	Data
N/A	Ramp Length (in)	52.0	No	Ramp Slope (%)	19.0
Yes	Ramp Width (in)	48.0	No	Ramp XSlope (%)	6.4
N/A	Flare Type LT	N/A	N/A	Flare Type RT	N/A
N/A	Flare Slope LT (%)	N/A	N/A	Flare Slope RT (%)	N/A
N/A	Flare Traversable LT?	N/A	N/A	Flare Traversable RT?	N/A
N/A	Landing Length (in)	N/A	N/A	DWS Provided?	N/A
N/A	Landing Width (in)	N/A	N/A	DWS Contrast?	N/A
N/A	Landing Slope (%)	N/A	N/A	DWS Length (in)	N/A
N/A	Landing X Slope (%)	N/A	N/A	DWS Full Width?	N/A
N/A	Landing Curb? (Y/N)	N/A	N/A	DWS Offset (in)	N/A
N/A	Shared Landing?	N/A			
N/A	Gutter Ponding?	N/A	N/A	Gutter Slope (%)	N/A
N/A	Gutter Lip Ht (in)	N/A	N/A	Gutter X Slope (%)	N/A
N/A	Painted X Walk1?	No	N/A	Painted X Walk2?	No
	X Walk 1 Direction	To SW		X Walk 2 Direction	To SE
N/A	X Walk 1 Width (in)	N/A	N/A	X Walk 2 Width (in)	N/A
	X Walk 1 Slope (%)	3.6		X Walk 2 Slope (%)	2.5
	X Walk 1 X Slope (%)	2.3		X Walk 2 X Slope (%)	5.2

N/A	Ramp inside XWalk1?	N/A	N/A	Ramp inside XWalk2?	N/A
	Road Slope (%)	2.6	N/A	Clear Space?	N/A
	Road X Slope (%)	1.9	N/A	Clear Space to XWalk (in)	N/A
N/A	Any Obstructions?	N/A	N/A	Storm Grate/Utility Hazard?	N/A
	Obstruction Type			Storm Grate/Utility Type	
		N/A			N/A
Yes	Surface Condition? (G/P)				Good

Possible Solutions:
Remove & Replace Curb Ramp With Two New Directional Ramps or Equivalent.

Total Cost: \$ **3200.00**
