Intersection ID: 19317	Main Street: COLONY_RD	Cross Street: WICKERSHAM_RD	Location:	SW
ADA ID: 51313E06027B	Ramp Type: ParaDiag	Initial Pass/Fail: Fail	Overall Compliance: No	Severity Score: 13.75

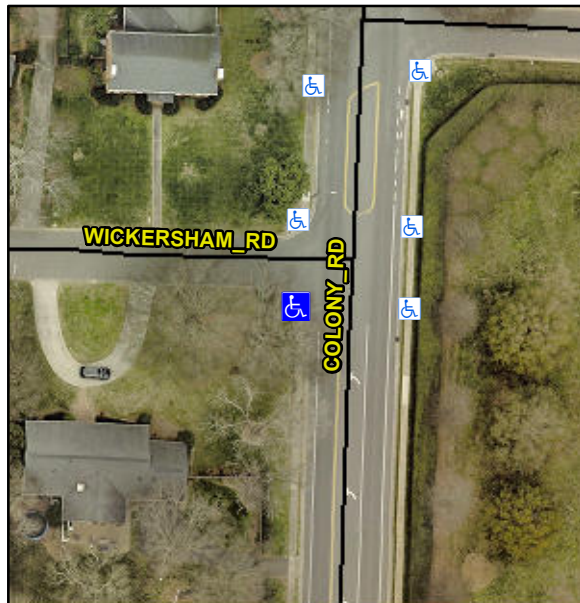
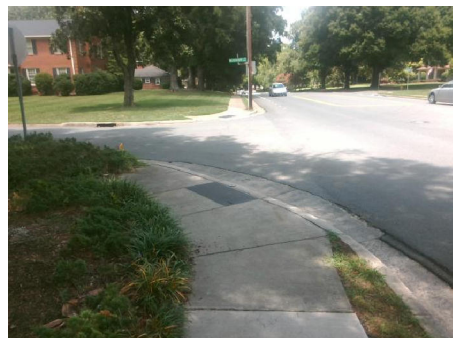
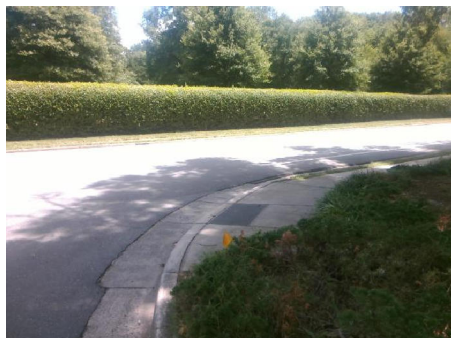
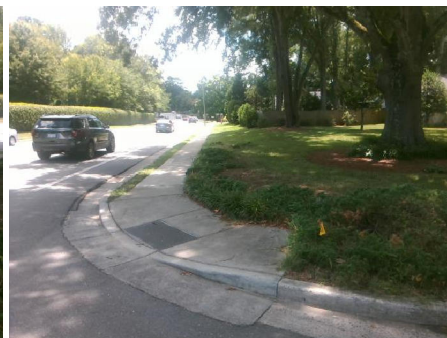
LT RP < 5%

R304.3.2, R304.5.3

Compliance	Description	Data	Compliance	Description	Data
N/A	Ramp Length LT (in)	47.0	N/A	Ramp Length RT (in)	48.0
Yes	Ramp Width LT (in)	62.0	Yes	Ramp Width RT (in)	62.0
Yes	Ramp Slope LT (%)	3.9	No	Ramp Slope RT (%)	8.8
Yes	Ramp XSlope LT (%)	1.8	No	Ramp XSlope RT (%)	3.6
N/A	Landing Length (in)	N/A	N/A	DWS Provided?	N/A
N/A	Landing Width (in)	N/A	N/A	DWS Contrast?	N/A
N/A	Landing Slope (%)	N/A	N/A	DWS Length (in)	N/A
N/A	Landing X Slope (%)	N/A	N/A	DWS Full Width?	N/A
N/A	Landing Curb? (Y/N)	N/A	N/A	DWS Offset (in)	N/A
N/A	Shared Landing?	N/A			
N/A	Gutter Ponding?	N/A	N/A	Gutter Slope (%)	N/A
N/A	Gutter Lip Ht (in)	N/A	N/A	Gutter X Slope (%)	N/A
N/A	Painted X Walk1?	No	N/A	Painted X Walk2?	No
	X Walk 1 Direction	To E		X Walk 2 Direction	To N
N/A	X Walk 1 Width (in)	N/A	N/A	X Walk 2 Width (in)	N/A
	X Walk 1 Slope (%)	9.2		X Walk 2 Slope (%)	3.4
	X Walk 1 X Slope (%)	2.7		X Walk 2 X Slope (%)	4.2
N/A	Ramp inside XWalk1?	N/A	N/A	Ramp inside XWalk2?	N/A

Road Slope (%)	0.1	N/A	Clear Space?	N/A
	Road X Slope (%)	5.9	N/A	Clear Space to XWalk (in)	N/A
N/A	Any Obstructions?	N/A	N/A	Storm Grate/Utility Hazard?	N/A
	Obstruction Type			Storm Grate/Utility Type	
		N/A			N/A
			Yes	Surface Condition? (G/P)	Good
			N/A	Curb Slope (%)	4.3

Remove & Replace Curb Ramp With Two New Directional Ramps or Equivalent.
