Access Compliance Report Public Rights-of-Way (Curb Ramps)

Intersection ID: 15023 Main Street: FAIRWOOD AV **Cross Street: S TRYON ST** Location: ADA ID: 51338525BF0D Ramp Type: PerpDiag Initial Pass/Fail: Fail **Overall Compliance: No Severity Score:** 22.5

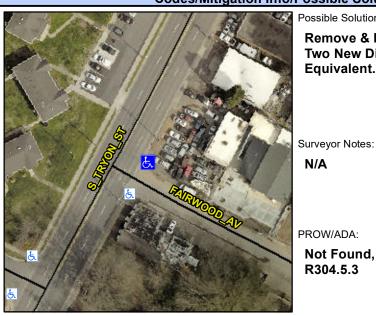
Compliance Description		Data	Comp	liance	Description	Data
N/A	Ramp Length (in)	60.0	No	Ramp	Slope (%)	11.5
No	Ramp Width (in)	44.0	No	Ramp XSlope (%)		4.1
N/A	Flare Type LT	N/A	N/A	Flare Type RT		N/A
N/A	Flare Slope LT (%)	N/A	N/A	Flare	Slope RT (%)	N/A
N/A	Flare Traversable LT?	N/A	N/A	Flare	Traversable RT?	N/A
N/A	Landing Length (in)	N/A	N/A	DWS	Provided?	N/A
N/A	Landing Width (in)	N/A	N/A	DWS	Contrast?	N/A
N/A	Landing Slope (%)	N/A	N/A	DWS	Length (in)	N/A
N/A	Landing X Slope (%)	N/A	N/A	DWS	Full Width?	N/A
N/A	Landing Curb? (Y/N)	N/A	N/A	DWS	Offset (in)	N/A
N/A	Shared Landing?	N/A				
N/A	Gutter Ponding?	N/A	N/A	Gutte	r Slope (%)	N/A
N/A	Gutter Lip Ht (in)	N/A	N/A	Gutte	r X Slope (%)	N/A
N/A	Painted X Walk1?	No	N/A	Paint	ed X Walk2?	No
	X Walk 1 Direction	To NW		X Wa	lk 2 Direction	To SW
N/A	X Walk 1 Width (in)	N/A	N/A	X Wa	lk 2 Width (in)	N/A
	X Walk 1 Slope (%)	3.6		X Wa	lk 2 Slope (%)	1.8
	X Walk 1 X Slope (%)	0.2		X Wa	lk 2 X Slope (%)	3.2

N/A	Ramp inside XWalk1?	N/A	N/A	Ram	inside XWalk2?	N/A
	Road Slope (%)	2.8	N/A	Clear	Space?	N/A
	Road X Slope (%)	2.7	N/A	Clear	Space to XWalk (in)	N/A
N/A	Any Obstructions?	N/A	N/A	Storn	n Grate/Utility Hazard?	N/A
	Obstruction Type			Storn	n Grate/Utility Type	
		N/A				N/A
			Yes	Surfa	ce Condition? (G/P)	Good

S TRYON ST None **FAIRWOOD AV** StopSign Possible Solutions: Remove & Replace Curb Ramp With **Two New Directional Ramps or** Equivalent.

Not Found, R304.5.1, R304.2.2, R304.5.3
