# Access Compliance Report

## Public Rights-of-Way

### (Curb Ramps)

Intersection ID: 51491	Main Street: N_TRYON_ST	Cross Street: INSTITUTE_CR	Location: S
ADA ID: 5138CE6FDC89	Ramp Type: Perp	Initial Pass/Fail: Fail	Overall Compliance: No
Severity Score: 21.25			
Codes/Mitigation Info/Possible Solution		Field Measurements/Component Compliance

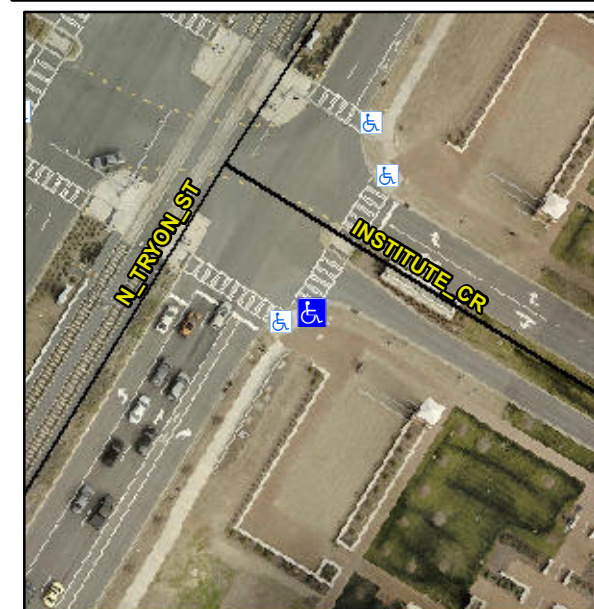
Compliance	Description	Data	Compliance	Description	Data
N/A	Ramp Length (in)	114.5	Yes	Ramp Slope (%)	5.0
No	Ramp Width (in)	47.5	No	Ramp XSlope (%)	5.3
N/A	Flare Type LT	N/A	N/A	Flare Type RT	N/A
N/A	Flare Slope LT (%)	N/A	N/A	Flare Slope RT (%)	N/A
N/A	Flare Traversable LT?	N/A	N/A	Flare Traversable RT?	N/A
N/A	Landing Length (in)	N/A	N/A	DWS Provided?	N/A
N/A	Landing Width (in)	N/A	N/A	DWS Contrast?	N/A
N/A	Landing Slope (%)	N/A	N/A	DWS Length (in)	N/A
N/A	Landing X Slope (%)	N/A	N/A	DWS Full Width?	N/A
N/A	Landing Curb? (Y/N)	N/A	N/A	DWS Offset (in)	N/A
N/A	Shared Landing?	N/A			
N/A	Gutter Ponding?	N/A	N/A	Gutter Slope (%)	N/A
N/A	Gutter Lip Ht (in)	2.0	N/A	Gutter X Slope (%)	N/A
N/A	Painted X Walk1?	No	N/A	Painted X Walk2?	N/A
	X Walk 1 Direction	To NE		X Walk 2 Direction	N/A
N/A	X Walk 1 Width (in)	N/A	N/A	X Walk 2 Width (in)	N/A
	X Walk 1 Slope (%)	3.4		X Walk 2 Slope (%)	N/A
	X Walk 1 X Slope (%)	6.8		X Walk 2 X Slope (%)	N/A

N/A	Ramp inside XWalk1?	N/A	N/A	Ramp inside XWalk2?	N/A
	Road Slope (%)	N/A	N/A	Clear Space?	N/A
	Road X Slope (%)	N/A	N/A	Clear Space to XWalk (in)	N/A
N/A	Any Obstructions?	N/A	N/A	Storm Grate/Utility Hazard?	N/A
	Obstruction Type			Storm Grate/Utility Type	
		N/A			N/A
		Yes		Surface Condition? (G/P)	Good

Possible Solutions:

**Remove & Replace Entire Ramp.**

**R304.5.1, R304.5.3**

Total Cost: \$ 1850.00
