# Access Compliance Report

## Public Rights-of-Way

### (Curb Ramps)

Intersection ID: 42669	Main Street: THORNHAVEN_CT	Cross Street: WALLACE_CABIN_DR	Location: SE
ADA ID: 51586543462C	Ramp Type: PerpDiag	Initial Pass/Fail: Fail	Overall Compliance: No
			Severity Score: 18.75

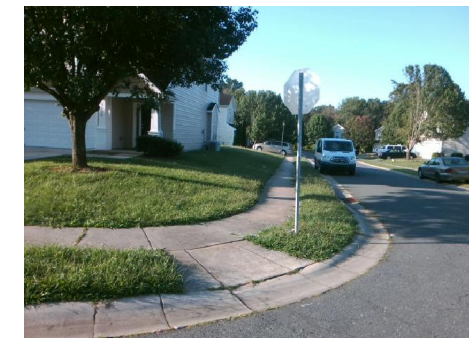
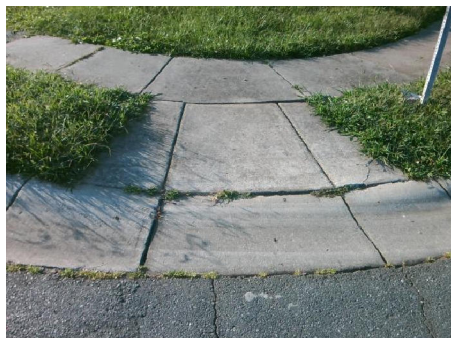
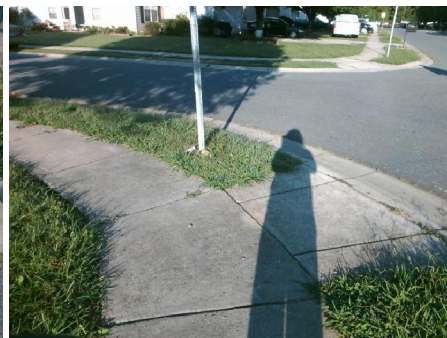
Compliance	Description	Data	Compliance	Description	Data
N/A	Ramp Length (in)	49.5	Yes	Ramp Slope (%)	6.0
No	Ramp Width (in)	33.0	No	Ramp XSlope (%)	2.9
N/A	Flare Type LT	N/A	N/A	Flare Type RT	N/A
N/A	Flare Slope LT (%)	N/A	N/A	Flare Slope RT (%)	N/A
N/A	Flare Traversable LT?	N/A	N/A	Flare Traversable RT?	N/A
N/A	Landing Length (in)	N/A	N/A	DWS Provided?	N/A
N/A	Landing Width (in)	N/A	N/A	DWS Contrast?	N/A
N/A	Landing Slope (%)	N/A	N/A	DWS Length (in)	N/A
N/A	Landing X Slope (%)	N/A	N/A	DWS Full Width?	N/A
N/A	Landing Curb? (Y/N)	N/A	N/A	DWS Offset (in)	N/A
N/A	Shared Landing?	N/A			
N/A	Gutter Ponding?	N/A	N/A	Gutter Slope (%)	N/A
N/A	Gutter Lip Ht (in)	0.5	N/A	Gutter X Slope (%)	N/A
N/A	Painted X Walk1?	No	N/A	Painted X Walk2?	No
	X Walk 1 Direction	To N		X Walk 2 Direction	To W
N/A	X Walk 1 Width (in)	N/A	N/A	X Walk 2 Width (in)	N/A
	X Walk 1 Slope (%)	3.9		X Walk 2 Slope (%)	1.4
	X Walk 1 X Slope (%)	0.1		X Walk 2 X Slope (%)	3.2

N/A	Ramp inside XWalk1?	N/A	N/A	Ramp inside XWalk2?	N/A
	Road Slope (%)	2.3	N/A	Clear Space?	N/A
	Road X Slope (%)	4.6	N/A	Clear Space to XWalk (in)	N/A
N/A	Any Obstructions?	N/A	N/A	Storm Grate/Utility Hazard?	N/A
	Obstruction Type			Storm Grate/Utility Type	
		N/A			N/A
			Yes	Surface Condition? (G/P)	Good

**Remove & Replace Curb Ramp With Two New Directional Ramps or Equivalent.**

**R304.5.1, R304.5.3**
