Access Compliance Report

Public Rights-of-Way

(Curb Ramps)

Intersection ID: 9648	Main Street: TIMBERBROOK_DR	Cross Street: TUCKASEEGEE_RD	Location: NW
ADA ID: 515AB8A161F6	Ramp Type: Perp	Initial Pass/Fail: Fail	Overall Compliance: No
		Severity Score: 1.25

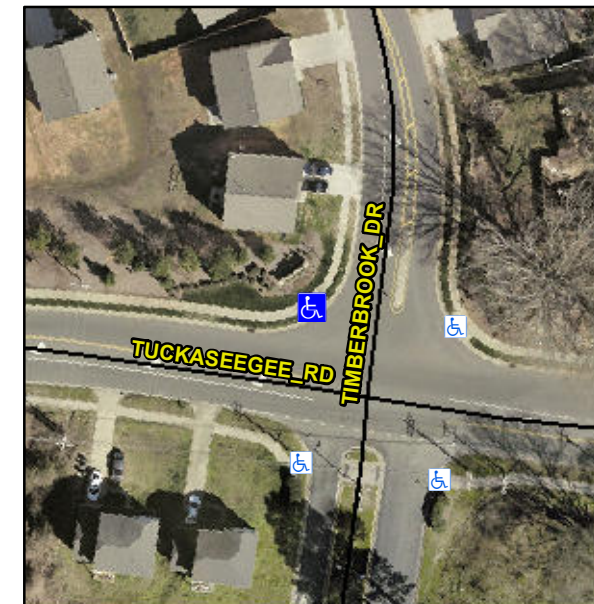
Not Found, R304.5.3

Compliance	Description	Data	Compliance	Description	Data
N/A	Ramp Length (in)	49.0	Yes	Ramp Slope (%)	5.4
Yes	Ramp Width (in)	54.0	No	Ramp XSlope (%)	2.4
N/A	Flare Type LT	N/A	N/A	Flare Type RT	N/A
N/A	Flare Slope LT (%)	N/A	N/A	Flare Slope RT (%)	N/A
N/A	Flare Traversable LT?	N/A	N/A	Flare Traversable RT?	N/A
N/A	Landing Length (in)	N/A	N/A	DWS Provided?	N/A
N/A	Landing Width (in)	N/A	N/A	DWS Contrast?	N/A
N/A	Landing Slope (%)	N/A	N/A	DWS Length (in)	N/A
N/A	Landing X Slope (%)	N/A	N/A	DWS Full Width?	N/A
N/A	Landing Curb? (Y/N)	N/A	N/A	DWS Offset (in)	N/A
N/A	Shared Landing?	N/A			
N/A	Gutter Ponding?	N/A	N/A	Gutter Slope (%)	N/A
N/A	Gutter Lip Ht (in)	N/A	N/A	Gutter X Slope (%)	N/A
N/A	Painted X Walk1?	No	N/A	Painted X Walk2?	N/A
	X Walk 1 Direction	To E		X Walk 2 Direction	N/A
N/A	X Walk 1 Width (in)	N/A	N/A	X Walk 2 Width (in)	N/A
	X Walk 1 Slope (%)	2.1		X Walk 2 Slope (%)	N/A
	X Walk 1 X Slope (%)	1.3		X Walk 2 X Slope (%)	N/A

N/A	Ramp inside XWalk1?	N/A	N/A	Ramp inside XWalk2?	N/A
	Road Slope (%)	N/A	N/A	Clear Space?	N/A
	Road X Slope (%)	N/A	N/A	Clear Space to XWalk (in)	N/A
N/A	Any Obstructions?	N/A	N/A	Storm Grate/Utility Hazard?	N/A
	Obstruction Type			Storm Grate/Utility Type	
		N/A			N/A
		Yes		Surface Condition? (G/P)	Good

Remove & Replace Entire Ramp.
