Access Compliance Report

Public Rights-of-Way

(Curb Ramps)

Intersection ID: 3031	Main Street: AMBER_GLEN_DR	Cross Street: AZURE_VALLEY_PL	Location:	N
ADA ID: 515D36F4EDDA	Ramp Type: Perp	Initial Pass/Fail: Fail	Overall Compliance: No	Severity Score: 18.75
Codes/Mitigation Info/Possible Solution		Field Measurements/Component Compliance

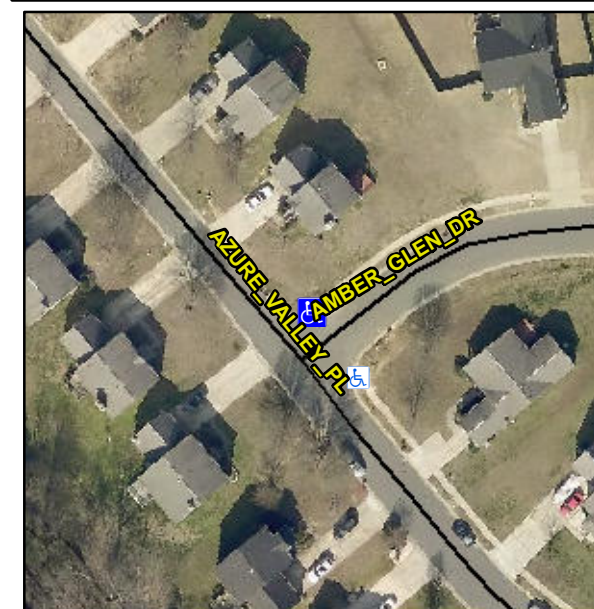
Not Found, R304.5.1, R304.5.3

Compliance	Description	Data	Compliance	Description	Data
N/A	Ramp Length (in)	51.0	Yes	Ramp Slope (%)	6.4
No	Ramp Width (in)	34.0	No	Ramp XSlope (%)	2.9
N/A	Flare Type LT	N/A	N/A	Flare Type RT	N/A
N/A	Flare Slope LT (%)	N/A	N/A	Flare Slope RT (%)	N/A
N/A	Flare Traversable LT?	N/A	N/A	Flare Traversable RT?	N/A
N/A	Landing Length (in)	N/A	N/A	DWS Provided?	N/A
N/A	Landing Width (in)	N/A	N/A	DWS Contrast?	N/A
N/A	Landing Slope (%)	N/A	N/A	DWS Length (in)	N/A
N/A	Landing X Slope (%)	N/A	N/A	DWS Full Width?	N/A
N/A	Landing Curb? (Y/N)	N/A	N/A	DWS Offset (in)	N/A
N/A	Shared Landing?	N/A			
N/A	Gutter Ponding?	N/A	N/A	Gutter Slope (%)	N/A
N/A	Gutter Lip Ht (in)	N/A	N/A	Gutter X Slope (%)	N/A
N/A	Painted X Walk1?	No	N/A	Painted X Walk2?	N/A
	X Walk 1 Direction	To SE		X Walk 2 Direction	N/A
N/A	X Walk 1 Width (in)	N/A	N/A	X Walk 2 Width (in)	N/A
	X Walk 1 Slope (%)	1.4		X Walk 2 Slope (%)	N/A
	X Walk 1 X Slope (%)	0.7		X Walk 2 X Slope (%)	N/A

N/A	Ramp inside XWalk1?	N/A	N/A	Ramp inside XWalk2?	N/A
	Road Slope (%)	N/A	N/A	Clear Space?	N/A
	Road X Slope (%)	N/A	N/A	Clear Space to XWalk (in)	N/A
N/A	Any Obstructions?	N/A	N/A	Storm Grate/Utility Hazard?	N/A
	Obstruction Type			Storm Grate/Utility Type	
		N/A			N/A
			Yes	Surface Condition? (G/P)	Good

Possible Solutions:

Remove & Replace Entire Ramp.

Total Cost: \$ 1850.00
