Access Compliance Report

Public Rights-of-Way

(Curb Ramps)

Intersection ID: 12560	Main Street: WILKINSON_BV	Cross Street: WEYLAND_AV	Location: NW
ADA ID: 5161DEDD69FB	Ramp Type: Perp	Initial Pass/Fail: Fail	Overall Compliance: No
Severity Score: 10			
Codes/Mitigation Info/Possible Solution		Field Measurements/Component Compliance

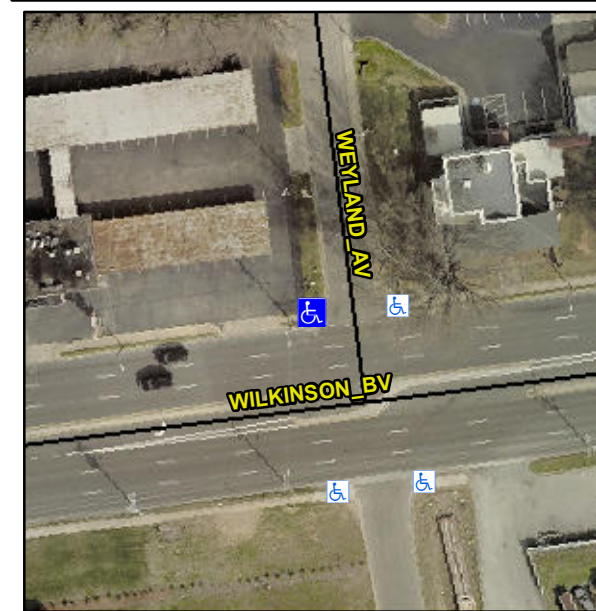
Not Found, R304.5.1, R304.5.3

Compliance	Description	Data	Compliance	Description	Data
N/A	Ramp Length (in)	54.5	Yes	Ramp Slope (%)	8.1
No	Ramp Width (in)	37.0	No	Ramp XSlope (%)	4.2
N/A	Flare Type LT	N/A	N/A	Flare Type RT	N/A
N/A	Flare Slope LT (%)	N/A	N/A	Flare Slope RT (%)	N/A
N/A	Flare Traversable LT?	N/A	N/A	Flare Traversable RT?	N/A
N/A	Landing Length (in)	N/A	N/A	DWS Provided?	N/A
N/A	Landing Width (in)	N/A	N/A	DWS Contrast?	N/A
N/A	Landing Slope (%)	N/A	N/A	DWS Length (in)	N/A
N/A	Landing X Slope (%)	N/A	N/A	DWS Full Width?	N/A
N/A	Landing Curb? (Y/N)	N/A	N/A	DWS Offset (in)	N/A
N/A	Shared Landing?	N/A			
N/A	Gutter Ponding?	N/A	N/A	Gutter Slope (%)	N/A
N/A	Gutter Lip Ht (in)	N/A	N/A	Gutter X Slope (%)	N/A
N/A	Painted X Walk1?	No	N/A	Painted X Walk2?	N/A
	X Walk 1 Direction	To E		X Walk 2 Direction	N/A
N/A	X Walk 1 Width (in)	N/A	N/A	X Walk 2 Width (in)	N/A
	X Walk 1 Slope (%)	2.8		X Walk 2 Slope (%)	N/A
	X Walk 1 X Slope (%)	3.1		X Walk 2 X Slope (%)	N/A

N/A	Ramp inside XWalk1?	N/A	N/A	Ramp inside XWalk2?	N/A
	Road Slope (%)	N/A	N/A	Clear Space?	N/A
	Road X Slope (%)	N/A	N/A	Clear Space to XWalk (in)	N/A
N/A	Any Obstructions?	N/A	N/A	Storm Grate/Utility Hazard?	N/A
	Obstruction Type			Storm Grate/Utility Type	
		N/A			N/A
			Yes	Surface Condition? (G/P)	Good

Possible Solutions:

Remove & Replace Entire Ramp.
