Access Compliance Report

Public Rights-of-Way

(Curb Ramps)

Intersection ID: 43998	Main Street: GANDER_DR	Cross Street: SUMMERBERRY_CT	Location: E
ADA ID: 516B46EEC353	Ramp Type: BlendTrans1	Initial Pass/Fail: Fail	Overall Compliance: No
Severity Score: 35			
Codes/Mitigation Info/Possible Solution		Field Measurements/Component Compliance

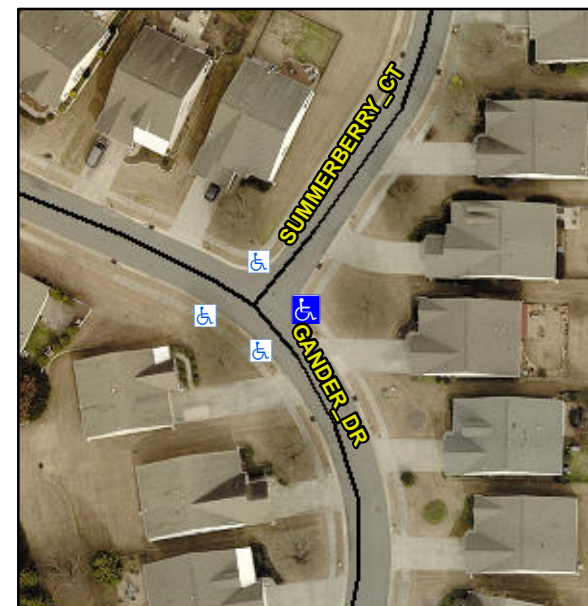
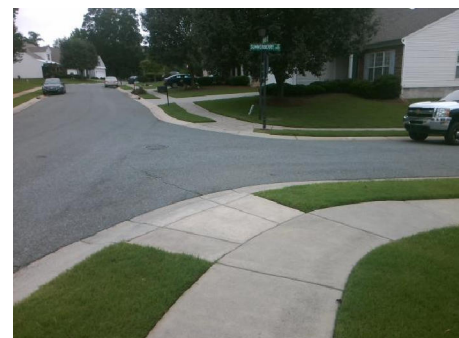
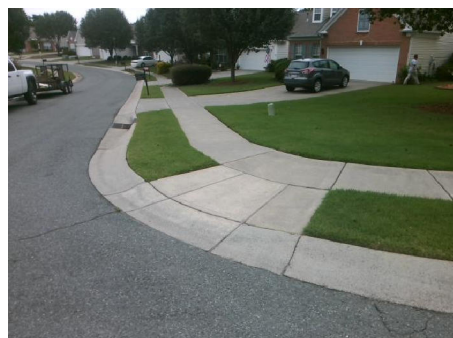
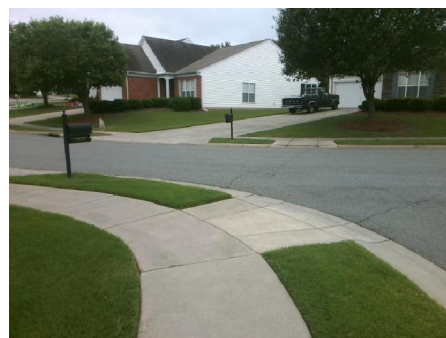
Not Found, R304.5.1

Compliance	Description	Data	Compliance	Description	Data
N/A	Ramp Length (in)	48.0	Yes	BlendTrans Slope (%)	4.4
No	Ramp Width (in)	29.0	Yes	BlendTrans XSlope (%)	1.1
N/A	Flare Type LT	N/A	N/A	Flare Type RT	N/A
N/A	Flare Slope LT (%)	N/A	N/A	Flare Slope RT (%)	N/A
N/A	Flare Traversable LT?	N/A	N/A	Flare Traversable RT?	N/A
N/A	Landing Length (in)	N/A	N/A	DWS Provided?	N/A
N/A	Landing Width (in)	N/A	N/A	DWS Contrast?	N/A
N/A	Landing Slope (%)	N/A	N/A	DWS Length (in)	N/A
N/A	Landing X Slope (%)	N/A	N/A	DWS Full Width?	N/A
N/A	Landing Curb? (Y/N)	N/A	N/A	DWS Offset (in)	N/A
N/A	Shared Landing?	N/A			
N/A	Gutter Ponding?	N/A	N/A	Gutter Slope (%)	N/A
N/A	Gutter Lip Ht (in)	N/A	N/A	Gutter X Slope (%)	N/A
N/A	Painted X Walk1?	No	N/A	Painted X Walk2?	No
	X Walk 1 Direction	To NW		X Walk 2 Direction	To SW
	X Walk 1 Width (in)	N/A		X Walk 2 Width (in)	N/A
	X Walk 1 Slope (%)	4.7		X Walk 2 Slope (%)	8.3
	X Walk 1 X Slope (%)	4.2		X Walk 2 X Slope (%)	2.3

N/A	Ramp inside XWalk1?	N/A	N/A	Ramp inside XWalk2?	N/A
	Road Slope (%)	0.6		Clear Space?	N/A
	Road X Slope (%)	6.3	N/A	Clear Space to XWalk (in)	N/A
N/A	Any Obstructions?	N/A	N/A	Storm Grate/Utility Hazard?	N/A
	Obstruction Type			Storm Grate/Utility Type	
		N/A			N/A
			Yes	Surface Condition? (G/P)	Good
			No	Curb Slope (%)	10.2

Remove & Replace Curb Ramp With Two New Directional Ramps or Equivalent.
