Access Compliance Report

Public Rights-of-Way

(Curb Ramps)

Intersection ID: 5749	Main Street: NEVIN_RD	Cross Street: WHITE_PINE_LN	Location: SE
ADA ID: 516B998FECBB	Ramp Type: Perp	Initial Pass/Fail: Fail	Overall Compliance: No
		Severity Score: 10

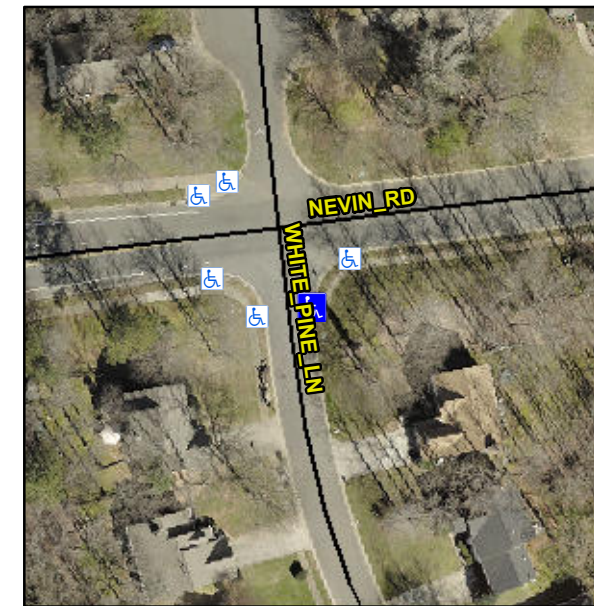
Not Found, R304.5.1, R304.5.3

Compliance	Description	Data	Compliance	Description	Data
N/A	Ramp Length (in)	46.0	Yes	Ramp Slope (%)	6.6
No	Ramp Width (in)	47.0	No	Ramp XSlope (%)	2.8
N/A	Flare Type LT	N/A	N/A	Flare Type RT	N/A
N/A	Flare Slope LT (%)	N/A	N/A	Flare Slope RT (%)	N/A
N/A	Flare Traversable LT?	N/A	N/A	Flare Traversable RT?	N/A
N/A	Landing Length (in)	N/A	N/A	DWS Provided?	N/A
N/A	Landing Width (in)	N/A	N/A	DWS Contrast?	N/A
N/A	Landing Slope (%)	N/A	N/A	DWS Length (in)	N/A
N/A	Landing X Slope (%)	N/A	N/A	DWS Full Width?	N/A
N/A	Landing Curb? (Y/N)	N/A	N/A	DWS Offset (in)	N/A
N/A	Shared Landing?	N/A			
N/A	Gutter Ponding?	N/A	N/A	Gutter Slope (%)	N/A
N/A	Gutter Lip Ht (in)	N/A	N/A	Gutter X Slope (%)	N/A
N/A	Painted X Walk1?	No	N/A	Painted X Walk2?	N/A
	X Walk 1 Direction	To W		X Walk 2 Direction	N/A
N/A	X Walk 1 Width (in)	N/A	N/A	X Walk 2 Width (in)	N/A
	X Walk 1 Slope (%)	5.1		X Walk 2 Slope (%)	N/A
	X Walk 1 X Slope (%)	3.1		X Walk 2 X Slope (%)	N/A

N/A	Ramp inside XWalk1?	N/A	N/A	Ramp inside XWalk2?	N/A
	Road Slope (%)	N/A	N/A	Clear Space?	N/A
	Road X Slope (%)	N/A	N/A	Clear Space to XWalk (in)	N/A
N/A	Any Obstructions?	N/A	N/A	Storm Grate/Utility Hazard?	N/A
	Obstruction Type			Storm Grate/Utility Type	
		N/A			N/A
			Yes	Surface Condition? (G/P)	Good

Possible Solutions:

Remove & Replace Entire Ramp.
