# Access Compliance Report

## Public Rights-of-Way

### (Curb Ramps)

Intersection ID: 46602	Main Street: PARK_RD_SHOPPING_CENTER_DR	Cross Street: PARK_RD	Location: NE
ADA ID: 516CB5257959	Ramp Type: PerpDiag	Initial Pass/Fail: Fail	Overall Compliance: No
		Severity Score: 8.75

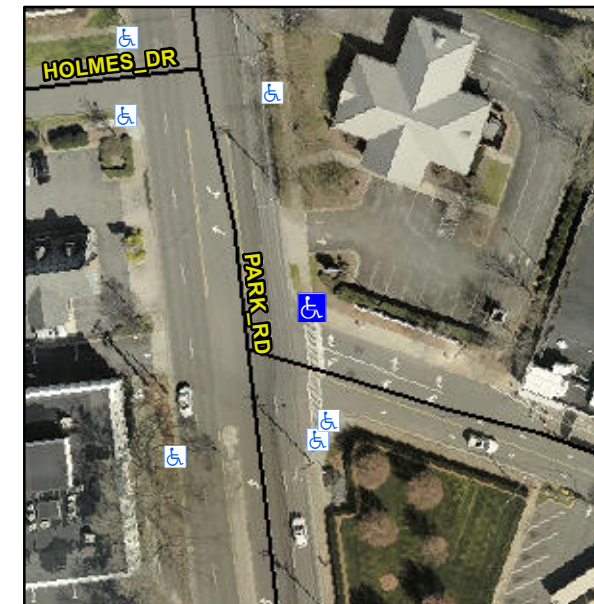
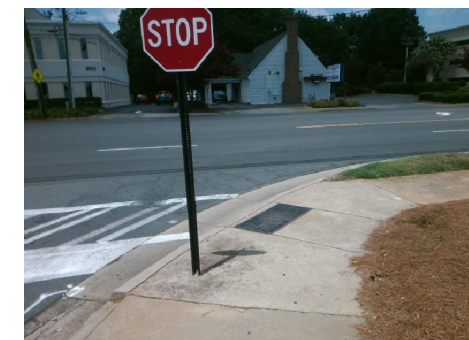
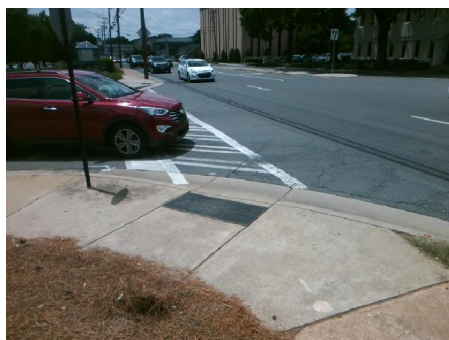
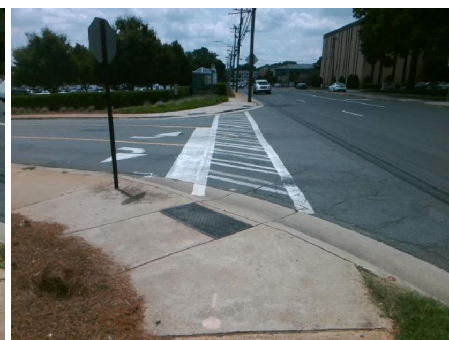
**Not Found, R304.5.1**

Compliance	Description	Data	Compliance	Description	Data
N/A	Ramp Length (in)	77.0	Yes	Ramp Slope (%)	5.3
No	Ramp Width (in)	45.0	Yes	Ramp XSlope (%)	0.4
N/A	Flare Type LT	N/A	N/A	Flare Type RT	N/A
N/A	Flare Slope LT (%)	N/A	N/A	Flare Slope RT (%)	N/A
N/A	Flare Traversable LT?	N/A	N/A	Flare Traversable RT?	N/A
N/A	Landing Length (in)	N/A	N/A	DWS Provided?	N/A
N/A	Landing Width (in)	N/A	N/A	DWS Contrast?	N/A
N/A	Landing Slope (%)	N/A	N/A	DWS Length (in)	N/A
N/A	Landing X Slope (%)	N/A	N/A	DWS Full Width?	N/A
N/A	Landing Curb? (Y/N)	N/A	N/A	DWS Offset (in)	N/A
N/A	Shared Landing?	N/A			
N/A	Gutter Ponding?	N/A	N/A	Gutter Slope (%)	N/A
N/A	Gutter Lip Ht (in)	N/A	N/A	Gutter X Slope (%)	N/A
N/A	Painted X Walk1?	No	N/A	Painted X Walk2?	Yes
	X Walk 1 Direction	To W		X Walk 2 Direction	To S
N/A	X Walk 1 Width (in)	N/A	N/A	X Walk 2 Width (in)	60.0
	X Walk 1 Slope (%)	1.5		X Walk 2 Slope (%)	1.2
	X Walk 1 X Slope (%)	0.2		X Walk 2 X Slope (%)	2.3

N/A	Ramp inside XWalk1?	N/A	N/A	Ramp inside XWalk2?	Yes
	Road Slope (%)	2.0	N/A	Clear Space?	N/A
	Road X Slope (%)	2.9	N/A	Clear Space to XWalk (in)	N/A
N/A	Any Obstructions?	N/A	N/A	Storm Grate/Utility Hazard?	N/A
	Obstruction Type			Storm Grate/Utility Type	
		N/A			N/A
			Yes	Surface Condition? (G/P)	Good

**Remove & Replace Curb Ramp With Two New Directional Ramps or Equivalent.**

Total Cost: \$ 3200.00
