Access Compliance Report

Public Rights-of-Way

(Curb Ramps)

Intersection ID: 2869	Main Street: EDINMEADOW_LN	Cross Street: RIDGE_RD	Location: NE
ADA ID: 516F8A406E79	Ramp Type: Perp	Initial Pass/Fail: Fail	Overall Compliance: No
Severity Score: 22.5			
Codes/Mitigation Info/Possible Solution		Field Measurements/Component Compliance

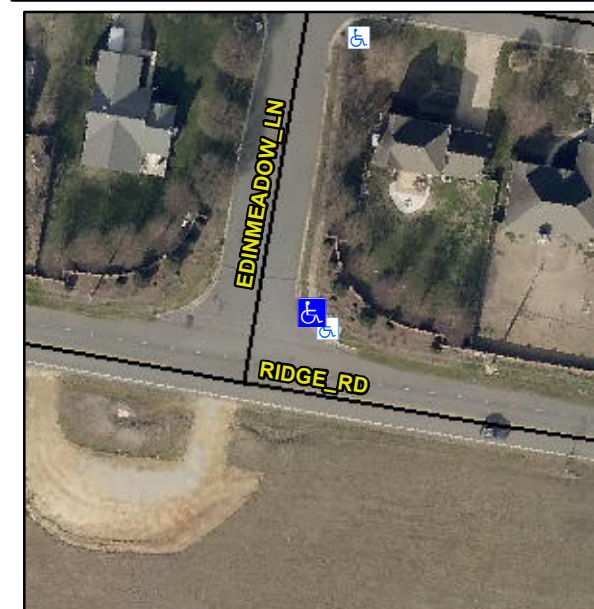
R304.5.1, R304.2.2, R304.5.3

Compliance	Description	Data	Compliance	Description	Data
N/A	Ramp Length (in)	48.0	No	Ramp Slope (%)	10.3
No	Ramp Width (in)	42.5	No	Ramp XSlope (%)	4.7
N/A	Flare Type LT	N/A	N/A	Flare Type RT	N/A
N/A	Flare Slope LT (%)	N/A	N/A	Flare Slope RT (%)	N/A
N/A	Flare Traversable LT?	N/A	N/A	Flare Traversable RT?	N/A
N/A	Landing Length (in)	N/A	N/A	DWS Provided?	N/A
N/A	Landing Width (in)	N/A	N/A	DWS Contrast?	N/A
N/A	Landing Slope (%)	N/A	N/A	DWS Length (in)	N/A
N/A	Landing X Slope (%)	N/A	N/A	DWS Full Width?	N/A
N/A	Landing Curb? (Y/N)	N/A	N/A	DWS Offset (in)	N/A
N/A	Shared Landing?	N/A			
N/A	Gutter Ponding?	N/A	N/A	Gutter Slope (%)	N/A
N/A	Gutter Lip Ht (in)	1.0	N/A	Gutter X Slope (%)	N/A
N/A	Painted X Walk1?	No	N/A	Painted X Walk2?	N/A
	X Walk 1 Direction	To NW		X Walk 2 Direction	N/A
N/A	X Walk 1 Width (in)	N/A	N/A	X Walk 2 Width (in)	N/A
	X Walk 1 Slope (%)	5.2		X Walk 2 Slope (%)	N/A
	X Walk 1 X Slope (%)	7.8		X Walk 2 X Slope (%)	N/A

N/A	Ramp inside XWalk1?	N/A	N/A	Ramp inside XWalk2?	N/A
	Road Slope (%)	N/A	N/A	Clear Space?	N/A
	Road X Slope (%)	N/A	N/A	Clear Space to XWalk (in)	N/A
N/A	Any Obstructions?	N/A	N/A	Storm Grate/Utility Hazard?	N/A
	Obstruction Type			Storm Grate/Utility Type	
		N/A			N/A
			Yes	Surface Condition? (G/P)	Good

Possible Solutions:

Remove & Replace Entire Ramp.
