Access Compliance Report Public Rights-of-Way (Curb Ramps)

Intersection ID: 28840 Main Street: FAIRGLEN_RD Cross Street: HEWITT_DR Location: SE

ADA ID: 5176504FA94F Ramp Type: BlendTrans1 Initial Pass/Fail: Fail Overall Compliance: No Severity Score: 12.5

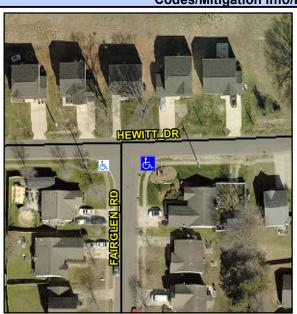
CURB LIP 2.0

Not Found, R304.5.3

Compliance Description Data Compliance Description Data Ramp Length (in) Yes N/A 95.0 BlendTrans Slope (%) 1.9 No Yes Ramp Width (in) 48.0 BlendTrans XSlope (%) 5.3 N/A N/A Flare Type LT N/A Flare Type RT N/A N/A Flare Slope LT (%) N/A N/A Flare Slope RT (%) N/A N/A Flare Traversable LT? N/A N/A Flare Traversable RT? N/A N/A Landing Length (in) N/A N/A **DWS Provided?** N/A N/A Landing Width (in) N/A N/A **DWS Contrast?** N/A N/A N/A N/A Landing Slope (%) DWS Length (in) N/A N/A Landing X Slope (%) N/A N/A DWS Full Width? N/A N/A Landing Curb? (Y/N) N/A N/A DWS Offset (in) N/A N/A N/A Shared Landing? N/A **Gutter Ponding?** N/A N/A Gutter Slope (%) N/A N/A Gutter Lip Ht (in) N/A N/A Gutter X Slope (%) N/A N/A Painted X Walk1? No N/A Painted X Walk2? N/A X Walk 1 Direction To W X Walk 2 Direction N/A N/A X Walk 2 Width (in) X Walk 1 Width (in) N/A X Walk 1 Slope (%) 1.8 X Walk 2 Slope (%) N/A X Walk 1 X Slope (%) 7.3 X Walk 2 X Slope (%) N/A N/A N/A Ramp inside XWalk2? N/A N/A Ramp inside XWalk1? Road Slope (%) 7.3 Clear Space? N/A N/A Road X Slope (%) Clear Space to XWalk (in) N/A 1.8 N/A N/A N/A Any Obstructions? Storm Grate/Utility Hazard? N/A **Obstruction Type** Storm Grate/Utility Type N/A N/A Yes Surface Condition? (G/P) Good No Curb Slope (%) 11.7

Remove & Replace Curb Ramp With
Two New Directional Ramps or
Equivalent.
