Intersection ID: 22202	Main Street: E_HEBRON_ST	Cross Street: HEBRON_COMMERCE_DR	Location:	SW
ADA ID: 51765E49BA66	Ramp Type: PerpDiag	Initial Pass/Fail: Fail	Overall Compliance: No	Severity Score: 46.25

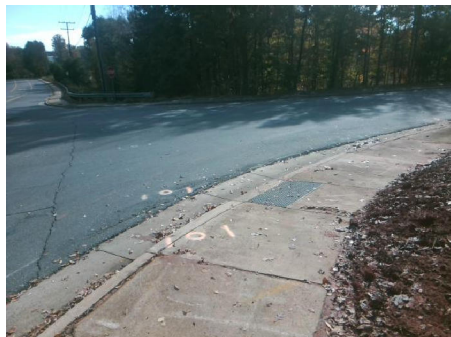
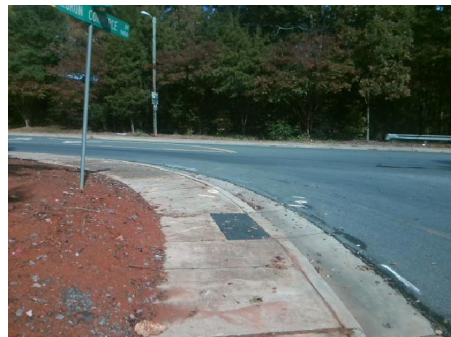
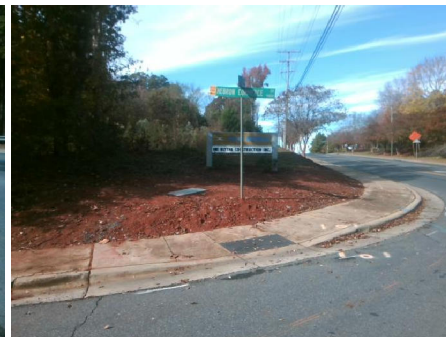
**Not Found, R304.5.1, R304.2.2,
R304.5.3**

Compliance	Description	Data	Compliance	Description	Data
N/A	Ramp Length (in)	60.0	No	Ramp Slope (%)	10.7
No	Ramp Width (in)	47.5	No	Ramp XSlope (%)	7.4
N/A	Flare Type LT	N/A	N/A	Flare Type RT	N/A
N/A	Flare Slope LT (%)	N/A	N/A	Flare Slope RT (%)	N/A
N/A	Flare Traversable LT?	N/A	N/A	Flare Traversable RT?	N/A
N/A	Landing Length (in)	N/A	N/A	DWS Provided?	N/A
N/A	Landing Width (in)	N/A	N/A	DWS Contrast?	N/A
N/A	Landing Slope (%)	N/A	N/A	DWS Length (in)	N/A
N/A	Landing X Slope (%)	N/A	N/A	DWS Full Width?	N/A
N/A	Landing Curb? (Y/N)	N/A	N/A	DWS Offset (in)	N/A
N/A	Shared Landing?	N/A			
N/A	Gutter Ponding?	N/A	N/A	Gutter Slope (%)	N/A
N/A	Gutter Lip Ht (in)	N/A	N/A	Gutter X Slope (%)	N/A
N/A	Painted X Walk1?	No	N/A	Painted X Walk2?	No
	X Walk 1 Direction	To SE		X Walk 2 Direction	To NE
N/A	X Walk 1 Width (in)	N/A	N/A	X Walk 2 Width (in)	N/A
	X Walk 1 Slope (%)	7.4		X Walk 2 Slope (%)	2.0
	X Walk 1 X Slope (%)	3.5		X Walk 2 X Slope (%)	7.5

N/A	Ramp inside XWalk1?	N/A	N/A	Ramp inside XWalk2?	N/A
	Road Slope (%)	6.8	N/A	Clear Space?	N/A
	Road X Slope (%)	6.6	N/A	Clear Space to XWalk (in)	N/A
N/A	Any Obstructions?	N/A	N/A	Storm Grate/Utility Hazard?	N/A
	Obstruction Type			Storm Grate/Utility Type	
		N/A			N/A
			Yes	Surface Condition? (G/P)	Good

Remove & Replace Curb Ramp With Two New Directional Ramps or Equivalent.
