# Access Compliance Report

## Public Rights-of-Way

### (Curb Ramps)

Intersection ID: 20640	Main Street: S_TRYON_ST	Cross Street: YAGER_CREEK_DR	Location: W
ADA ID: 518C3741F29E	Ramp Type: Perp	Initial Pass/Fail: Pass	Overall Compliance: No
Codes/Mitigation Info/Possible Solution		Field Measurements/Component Compliance	
Severity Score: 27.75

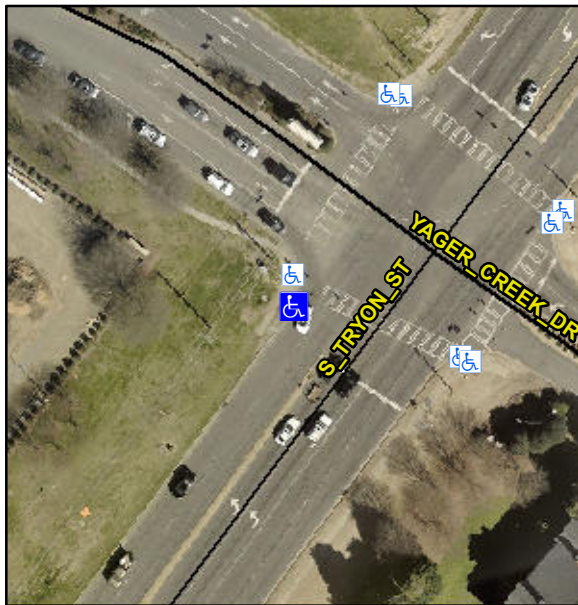
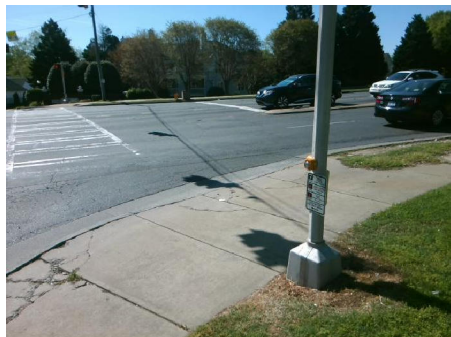
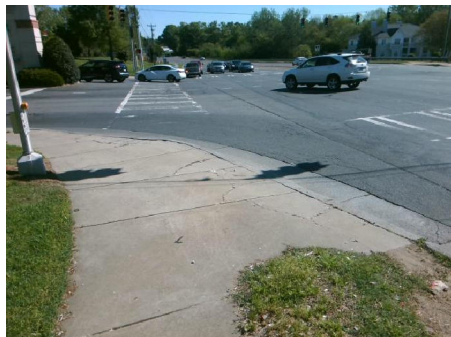
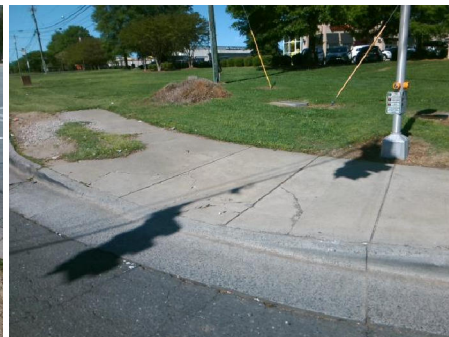
**Not Found, R304.5.3, R304.2.1,  
R304.2.2-Perp, R304.3.2-Para, R305,  
R207.1, R302.7.2**

Compliance	Description	Data	Compliance	Description	Data
N/A	Ramp Length (in)	102.0	Yes	Ramp Slope (%)	6.2
Yes	Ramp Width (in)	48.0	No	Ramp XSlope (%)	3.5
N/A	Flare Type LT	Sloped	N/A	Flare Type RT	N/A
N/A	Flare Slope LT (%)	9.6	Yes	Flare Slope RT (%)	6.3
N/A	Flare Traversable LT?	Yes	N/A	Flare Traversable RT?	Yes
No	Landing Length (in)	N/A	No	DWS Provided?	No
No	Landing Width (in)	N/A	N/A	DWS Contrast?	No
No	Landing Slope (%)	N/A	N/A	DWS Length (in)	N/A
No	Landing X Slope (%)	N/A	N/A	DWS Full Width?	No
N/A	Landing Curb? (Y/N)	No	N/A	DWS Offset (in)	N/A
N/A	Shared Landing?	No			
Yes	Gutter Ponding?	No	Yes	Gutter Slope (%)	0.6
No	Gutter Lip Ht (in)	0.5	Yes	Gutter X Slope (%)	2.8
N/A	Painted X Walk1?	Yes	N/A	Painted X Walk2?	N/A
	X Walk 1 Direction	To SE		X Walk 2 Direction	N/A
N/A	X Walk 1 Width (in)	110.0	N/A	X Walk 2 Width (in)	N/A
	X Walk 1 Slope (%)	1.9		X Walk 2 Slope (%)	N/A
	X Walk 1 X Slope (%)	2.8		X Walk 2 X Slope (%)	N/A

No	Ramp inside XWalk1?	No	N/A	Ramp inside XWalk2?	N/A
	Road Slope (%)	N/A	N/A	Clear Space?	Yes
	Road X Slope (%)	N/A	N/A	Clear Space to XWalk (in)	N/A
Yes	Any Obstructions?	No	Yes	Storm Grate/Utility Hazard?	No
	Obstruction Type			Storm Grate/Utility Type	
		N/A			N/A
			Yes	Surface Condition? (G/P)	Good

**Remove & Replace Entire Ramp.  
Restripe Crosswalk.**
