Access Compliance Report

Public Rights-of-Way (Curb Ramps)

| Intersection ID: 20213 | Main Street: COLLINGHAM_DR | Cross Street: QUEENSMEAD_CR | Location: SE |
| ADA ID: 51927D2EAB01 | Ramp Type: Directional | Initial Pass/Fail: Fail | Overall Compliance: No |

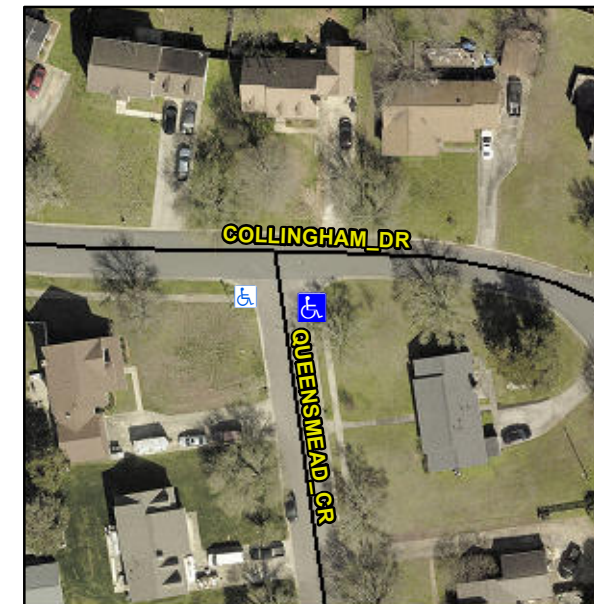
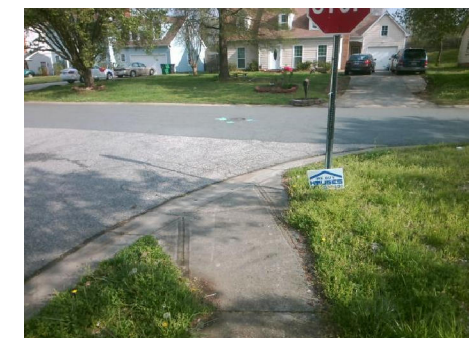
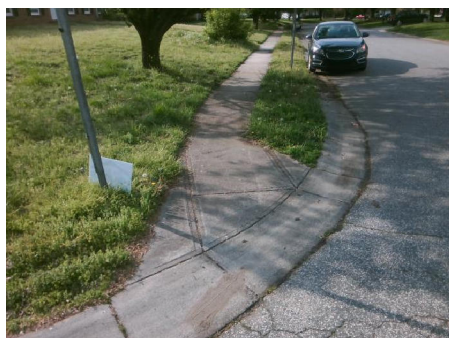
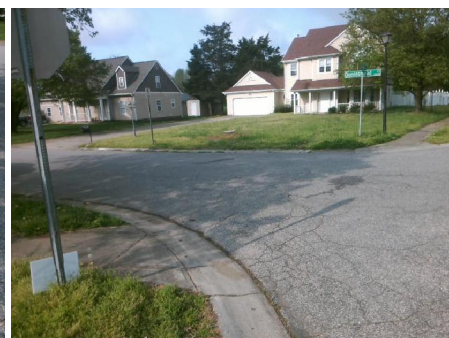
| | | Severity Score: 21.25 | |

R304.5.1, R304.5.3

| Compliance | Description | Data | Compliance | Description | Data |
|---|---|---|---|---|---|
| No | Ramp Width (in) | 45.0 | N/A | Grade Break Slope (%) | 0.0 |
| No | Ramp XSlope (%) | 6.0 | | | |

Remove & Replace Entire Ramp.

\$ 1600.00
