# Access Compliance Report

## Public Rights-of-Way

### (Curb Ramps)

Intersection ID: 53292	Main Street: PROSPERITY RIDGE RD	Cross Street: ROBERT HELMS RD	Location: W
ADA ID: 5197B9DF5C2C	Ramp Type: Perp	Initial Pass/Fail: Fail	Overall Compliance: No
Severity Score: 12.5			
Codes/Mitigation Info/Possible Solution		Field Measurements/Component Compliance

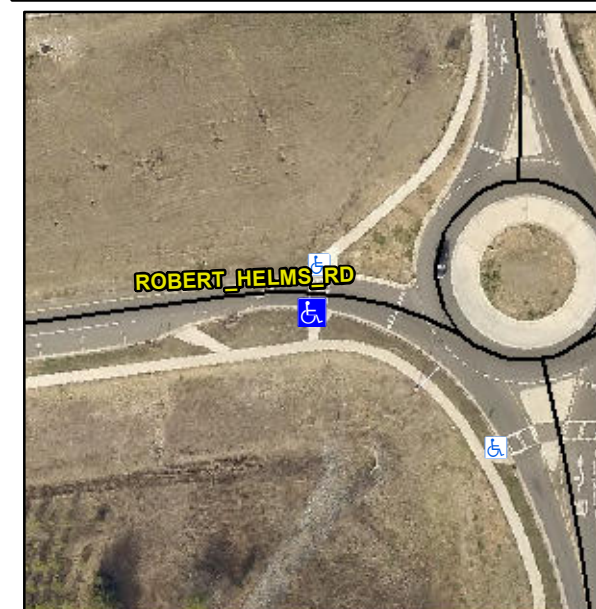
Compliance	Description	Data	Compliance	Description	Data
N/A	Ramp Length (in)	97.0	No	Ramp Slope (%)	8.8
Yes	Ramp Width (in)	48.0	Yes	Ramp XSlope (%)	1.3
N/A	Flare Type LT	N/A	N/A	Flare Type RT	N/A
N/A	Flare Slope LT (%)	N/A	N/A	Flare Slope RT (%)	N/A
N/A	Flare Traversable LT?	N/A	N/A	Flare Traversable RT?	N/A
N/A	Landing Length (in)	N/A	N/A	DWS Provided?	N/A
N/A	Landing Width (in)	N/A	N/A	DWS Contrast?	N/A
N/A	Landing Slope (%)	N/A	N/A	DWS Length (in)	N/A
N/A	Landing X Slope (%)	N/A	N/A	DWS Full Width?	N/A
N/A	Landing Curb? (Y/N)	N/A	N/A	DWS Offset (in)	N/A
N/A	Shared Landing?	N/A			
N/A	Gutter Ponding?	N/A	N/A	Gutter Slope (%)	N/A
N/A	Gutter Lip Ht (in)	N/A	N/A	Gutter X Slope (%)	N/A
N/A	Painted X Walk1?	Yes	N/A	Painted X Walk2?	N/A
	X Walk 1 Direction	To N		X Walk 2 Direction	N/A
N/A	X Walk 1 Width (in)	104.0	N/A	X Walk 2 Width (in)	N/A
	X Walk 1 Slope (%)	2.1		X Walk 2 Slope (%)	N/A
	X Walk 1 X Slope (%)	2.7		X Walk 2 X Slope (%)	N/A

N/A	Ramp inside XWalk1?	Yes	N/A	Ramp inside XWalk2?	N/A
	Road Slope (%)	N/A	N/A	Clear Space?	N/A
	Road X Slope (%)	N/A	N/A	Clear Space to XWalk (in)	N/A
N/A	Any Obstructions?	N/A	N/A	Storm Grate/Utility Hazard?	N/A
	Obstruction Type			Storm Grate/Utility Type	
		N/A			N/A
		Yes		Surface Condition? (G/P)	Good

Possible Solutions:

**Remove & Replace Entire Ramp.**

**R304.2.2**

**\$ 1850.00**
