# Access Compliance Report

## Public Rights-of-Way

### (Curb Ramps)

Intersection ID: 12544	Main Street: E_8TH_ST	Cross Street: N_ALEXANDER_ST	Location: W
ADA ID: 51A05841C443	Ramp Type: PerpDiag	Initial Pass/Fail: Fail	Overall Compliance: No
			Severity Score: 33.75

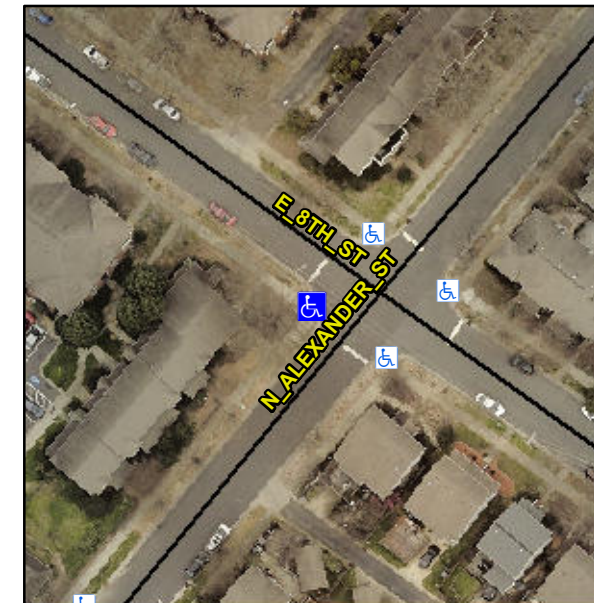
**Not Found, R304.5.1, R304.2.2, R304.5.3**

Compliance	Description	Data	Compliance	Description	Data
N/A	Ramp Length (in)	29.0	No	Ramp Slope (%)	10.3
No	Ramp Width (in)	36.0	No	Ramp XSlope (%)	5.3
N/A	Flare Type LT	N/A	N/A	Flare Type RT	N/A
N/A	Flare Slope LT (%)	N/A	N/A	Flare Slope RT (%)	N/A
N/A	Flare Traversable LT?	N/A	N/A	Flare Traversable RT?	N/A
N/A	Landing Length (in)	N/A	N/A	DWS Provided?	N/A
N/A	Landing Width (in)	N/A	N/A	DWS Contrast?	N/A
N/A	Landing Slope (%)	N/A	N/A	DWS Length (in)	N/A
N/A	Landing X Slope (%)	N/A	N/A	DWS Full Width?	N/A
N/A	Landing Curb? (Y/N)	N/A	N/A	DWS Offset (in)	N/A
N/A	Shared Landing?	N/A			
N/A	Gutter Ponding?	N/A	N/A	Gutter Slope (%)	N/A
N/A	Gutter Lip Ht (in)	N/A	N/A	Gutter X Slope (%)	N/A
N/A	Painted X Walk1?	No	N/A	Painted X Walk2?	No
	X Walk 1 Direction	To SE		X Walk 2 Direction	To NE
N/A	X Walk 1 Width (in)	N/A	N/A	X Walk 2 Width (in)	N/A
	X Walk 1 Slope (%)	9.2		X Walk 2 Slope (%)	11.5
	X Walk 1 X Slope (%)	12.1		X Walk 2 X Slope (%)	7.0

N/A	Ramp inside XWalk1?	N/A	N/A	Ramp inside XWalk2?	N/A
	Road Slope (%)	5.5	N/A	Clear Space?	N/A
	Road X Slope (%)	14.3	N/A	Clear Space to XWalk (in)	N/A
N/A	Any Obstructions?	N/A	N/A	Storm Grate/Utility Hazard?	N/A
	Obstruction Type			Storm Grate/Utility Type	
		N/A			N/A
			Yes	Surface Condition? (G/P)	Good

**Remove & Replace Curb Ramp With Two New Directional Ramps or Equivalent.**

Total Cost: \$ 3200.00
