Access Compliance Report

Public Rights-of-Way

(Curb Ramps)

Intersection ID: 43472	Main Street: S_TRYON_ST	Cross Street: LIONS_MANE_ST	Location: SW
ADA ID: 51BE7AB0E6F9	Ramp Type: Perp	Initial Pass/Fail: Fail	Overall Compliance: No
Severity Score: 33.75			
Codes/Mitigation Info/Possible Solution		Field Measurements/Component Compliance

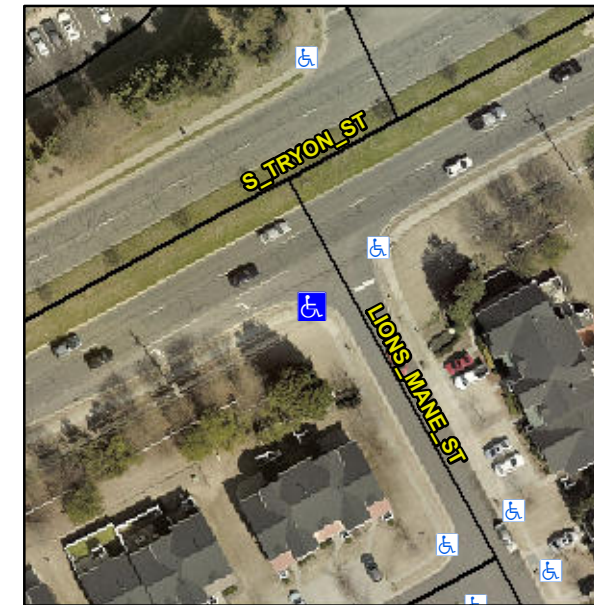
R304.5.1, R304.2.2, R304.5.3

Compliance	Description	Data	Compliance	Description	Data
N/A	Ramp Length (in)	91.0	No	Ramp Slope (%)	10.0
No	Ramp Width (in)	46.0	No	Ramp XSlope (%)	5.1
N/A	Flare Type LT	N/A	N/A	Flare Type RT	N/A
N/A	Flare Slope LT (%)	N/A	N/A	Flare Slope RT (%)	N/A
N/A	Flare Traversable LT?	N/A	N/A	Flare Traversable RT?	N/A
N/A	Landing Length (in)	N/A	N/A	DWS Provided?	N/A
N/A	Landing Width (in)	N/A	N/A	DWS Contrast?	N/A
N/A	Landing Slope (%)	N/A	N/A	DWS Length (in)	N/A
N/A	Landing X Slope (%)	N/A	N/A	DWS Full Width?	N/A
N/A	Landing Curb? (Y/N)	N/A	N/A	DWS Offset (in)	N/A
N/A	Shared Landing?	N/A			
N/A	Gutter Ponding?	N/A	N/A	Gutter Slope (%)	N/A
N/A	Gutter Lip Ht (in)	N/A	N/A	Gutter X Slope (%)	N/A
N/A	Painted X Walk1?	No	N/A	Painted X Walk2?	N/A
	X Walk 1 Direction	To NE		X Walk 2 Direction	N/A
N/A	X Walk 1 Width (in)	N/A	N/A	X Walk 2 Width (in)	N/A
	X Walk 1 Slope (%)	3.6		X Walk 2 Slope (%)	N/A
	X Walk 1 X Slope (%)	3.3		X Walk 2 X Slope (%)	N/A

N/A	Ramp inside XWalk1?	N/A	N/A	Ramp inside XWalk2?	N/A
	Road Slope (%)	N/A	N/A	Clear Space?	N/A
	Road X Slope (%)	N/A	N/A	Clear Space to XWalk (in)	N/A
N/A	Any Obstructions?	N/A	N/A	Storm Grate/Utility Hazard?	N/A
	Obstruction Type			Storm Grate/Utility Type	
		N/A			N/A
			Yes	Surface Condition? (G/P)	Good

Remove & Replace Entire Ramp.
