## Access Compliance Report Public Rights-of-Way (Curb Ramps)

Intersection ID: 13912 Main Street: E\_STONEWALL\_ST Cross Street: E\_JOHN\_BELK\_RA Location: NW

ADA ID: 51D86A1FA3E6 Ramp Type: Perp Initial Pass/Fail: Fail Overall Compliance: No Severity Score: 21.25

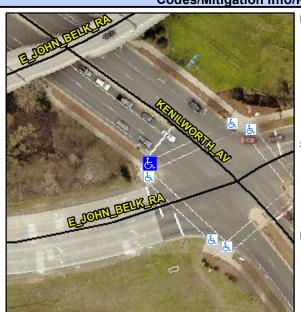
Not Found, R304.5.1, R304.5.3

Field Measurements/Component Compliance						
Compliance Description		Data	Comp	liance Description	Data	
N/	A Ramp Length (in)	47.5	Yes	Ramp Slope (%)	5.8	
No	Ramp Width (in)	47.0	No	Ramp XSlope (%)	5.2	
N/A	A Flare Type LT	N/A	N/A	Flare Type RT	N/A	
N/	A Flare Slope LT (%)	N/A	N/A	Flare Slope RT (%)	N/A	
N/	A Flare Traversable LT?	N/A	N/A	Flare Traversable RT?	N/A	
N/	A Landing Length (in)	N/A	N/A	DWS Provided?	N/A	
N/	A Landing Width (in)	N/A	N/A	DWS Contrast?	N/A	
N/	A Landing Slope (%)	N/A	N/A	DWS Length (in)	N/A	
N/	A Landing X Slope (%)	N/A	N/A	DWS Full Width?	N/A	
N/	A Landing Curb? (Y/N)	N/A	N/A	DWS Offset (in)	N/A	
N/	A Shared Landing?	N/A				
N/	A Gutter Ponding?	N/A	N/A	Gutter Slope (%)	N/A	
N/A	A Gutter Lip Ht (in)	N/A	N/A	Gutter X Slope (%)	N/A	
N/	A Painted X Walk1?	Yes	N/A	Painted X Walk2?	N/A	
	X Walk 1 Direction	To E		X Walk 2 Direction	N/A	
N/	A X Walk 1 Width (in)	117.0	N/A	X Walk 2 Width (in)	N/A

X Walk 1 Slope (%)	2.3		X Walk 2 Slope (%)	N/A	
	X Walk 1 X Slope (%)	4.2		X Walk 2 X Slope (%)	N/A	
N/	A Ramp inside XWalk1?	Yes	N/A	Ramp inside XWalk2?	N/A	
	Road Slope (%)	N/A	N/A	Clear Space?	N/A	
	Road X Slope (%)	N/A	N/A	Clear Space to XWalk (in)	N/A	
N/	A Any Obstructions?	N/A	N/A	Storm Grate/Utility Hazard?	N/A	
	Obstruction Type			Storm Grate/Utility Type		
		N/A			N/A	
			Yes	Surface Condition? (G/P)	Good

Possible Solutions:

Remove & Replace Entire Ramp.
