Access Compliance Report

Public Rights-of-Way

(Curb Ramps)

Intersection ID: 31349	Main Street: OAK_PASTURE_LN	Cross Street: SAGUARO_CT	Location:	N
ADA ID: 51D8BEB6F0B8	Ramp Type: PerpDiag	Initial Pass/Fail: Fail	Overall Compliance: No	Severity Score: 13.75
Codes/Mitigation Info/Possible Solution		Field Measurements/Component Compliance

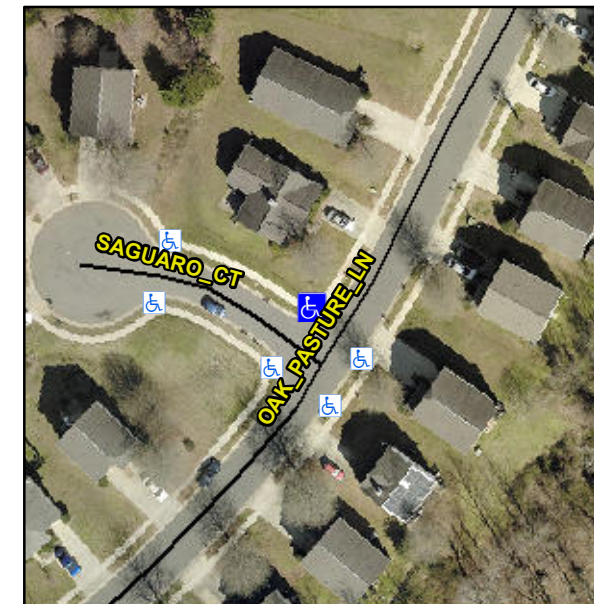
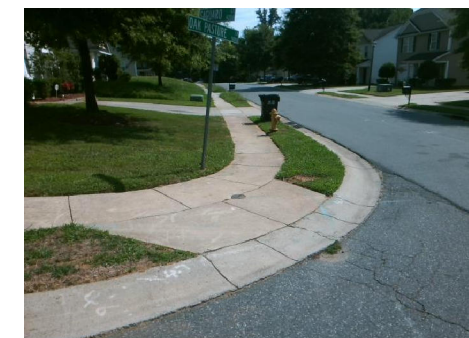
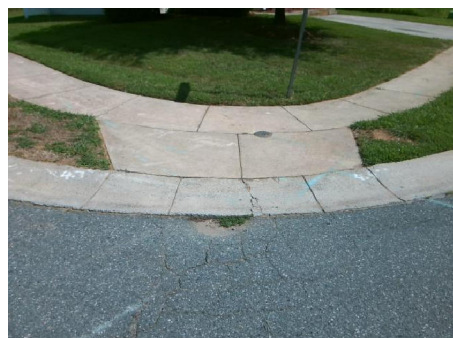
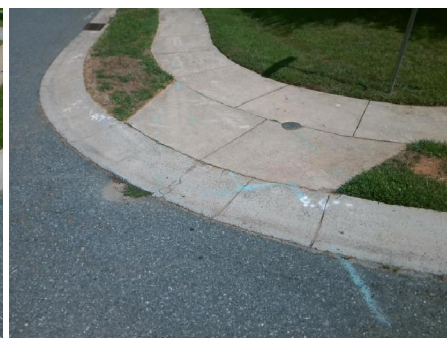
Not Found, R304.2.2, R304.5.3

Compliance	Description	Data	Compliance	Description	Data
N/A	Ramp Length (in)	48.0	No	Ramp Slope (%)	8.9
Yes	Ramp Width (in)	51.0	No	Ramp XSlope (%)	4.9
N/A	Flare Type LT	N/A	N/A	Flare Type RT	N/A
N/A	Flare Slope LT (%)	N/A	N/A	Flare Slope RT (%)	N/A
N/A	Flare Traversable LT?	N/A	N/A	Flare Traversable RT?	N/A
N/A	Landing Length (in)	N/A	N/A	DWS Provided?	N/A
N/A	Landing Width (in)	N/A	N/A	DWS Contrast?	N/A
N/A	Landing Slope (%)	N/A	N/A	DWS Length (in)	N/A
N/A	Landing X Slope (%)	N/A	N/A	DWS Full Width?	N/A
N/A	Landing Curb? (Y/N)	N/A	N/A	DWS Offset (in)	N/A
N/A	Shared Landing?	N/A			
N/A	Gutter Ponding?	N/A	N/A	Gutter Slope (%)	N/A
N/A	Gutter Lip Ht (in)	1.0	N/A	Gutter X Slope (%)	N/A
N/A	Painted X Walk1?	No	N/A	Painted X Walk2?	No
	X Walk 1 Direction	To SW		X Walk 2 Direction	To SE
N/A	X Walk 1 Width (in)	N/A	N/A	X Walk 2 Width (in)	N/A
	X Walk 1 Slope (%)	0.1		X Walk 2 Slope (%)	0.6
	X Walk 1 X Slope (%)	1.6		X Walk 2 X Slope (%)	3.6

N/A	Ramp inside XWalk1?	N/A	N/A	Ramp inside XWalk2?	N/A
	Road Slope (%)	0.0	N/A	Clear Space?	N/A
	Road X Slope (%)	1.9	N/A	Clear Space to XWalk (in)	N/A
N/A	Any Obstructions?	N/A	N/A	Storm Grate/Utility Hazard?	N/A
	Obstruction Type			Storm Grate/Utility Type	
		N/A			N/A
		Yes		Surface Condition? (G/P)	Good

Remove & Replace Curb Ramp With Two New Directional Ramps or Equivalent.
