Access Compliance Report

Public Rights-of-Way

(Curb Ramps)

Intersection ID: 10018887	Main Street: BISCAYNE_DR	Cross Street: N/A	Location: SE
ADA ID: 51DDD73F3E41	Ramp Type: Perp	Initial Pass/Fail: Fail	Overall Compliance: No
Codes/Mitigation Info/Possible Solution		Field Measurements/Component Compliance

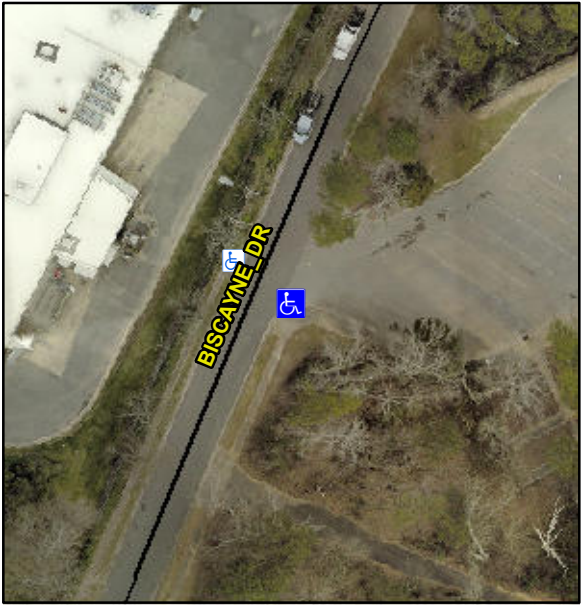
Possible Solutions:						
	Remove & Replace Entire Ramp.	N/A	Ramp Length (in)	56.0	No	Ramp Slope (%)	10.3
		Yes	Ramp Width (in)	55.0	No	Ramp XSlope (%)	3.5
		N/A	Flare Type LT	N/A	N/A	Flare Type RT	N/A
		N/A	Flare Slope LT (%)	N/A	N/A	Flare Slope RT (%)	N/A
		N/A	Flare Traversable LT?	N/A	N/A	Flare Traversable RT?	N/A
		N/A	Landing Length (in)	N/A	N/A	DWS Provided?	N/A
		N/A	Landing Width (in)	N/A	N/A	DWS Contrast?	N/A
		N/A	Landing Slope (%)	N/A	N/A	DWS Length (in)	N/A
		N/A	Landing X Slope (%)	N/A	N/A	DWS Full Width?	N/A
<p>Surveyor Notes:</p> <p>N/A</p> <p>PROW/ADA:</p> <p>Not Found, R304.2.2, R304.5.3</p>		N/A	Landing Curb? (Y/N)	N/A	N/A	DWS Offset (in)	N/A
		N/A	Shared Landing?	N/A			
		N/A	Gutter Ponding?	Yes	N/A	Gutter Slope (%)	N/A
		N/A	Gutter Lip Ht (in)	N/A	N/A	Gutter X Slope (%)	N/A
		N/A	Painted X Walk1?	No	N/A	Painted X Walk2?	N/A
			X Walk 1 Direction	To NW		X Walk 2 Direction	N/A
		N/A	X Walk 1 Width (in)	N/A	N/A	X Walk 2 Width (in)	N/A

X Walk 1 Slope (%)	2.2		X Walk 2 Slope (%)	N/A
			X Walk 1 X Slope (%)	1.3		X Walk 2 X Slope (%)	N/A
		N/A	Ramp inside XWalk1?	N/A	N/A	Ramp inside XWalk2?	N/A
<p>Street 1 Name</p> <p>Stop Condition-Street 2</p> <p>Street 2 Name</p> <p>Stop Condition-Street 1</p>			Road Slope (%)	N/A	N/A	Clear Space?	N/A
			Road X Slope (%)	N/A	N/A	Clear Space to XWalk (in)	N/A
		N/A	Any Obstructions?	N/A	N/A	Storm Grate/Utility Hazard?	N/A
			Obstruction Type			Storm Grate/Utility Type	
				N/A			N/A
					Yes	Surface Condition? (G/P)	Good
