Access Compliance Report

Public Rights-of-Way

(Curb Ramps)

Intersection ID: 15270	Main Street: GRIFFITH_ST	Cross Street: NEW_BERN_ST	Location: NE
ADA ID: 51E4FEEE74A1	Ramp Type: Perp	Initial Pass/Fail: Fail	Overall Compliance: No
Severity Score: 22.5			
Codes/Mitigation Info/Possible Solution		Field Measurements/Component Compliance

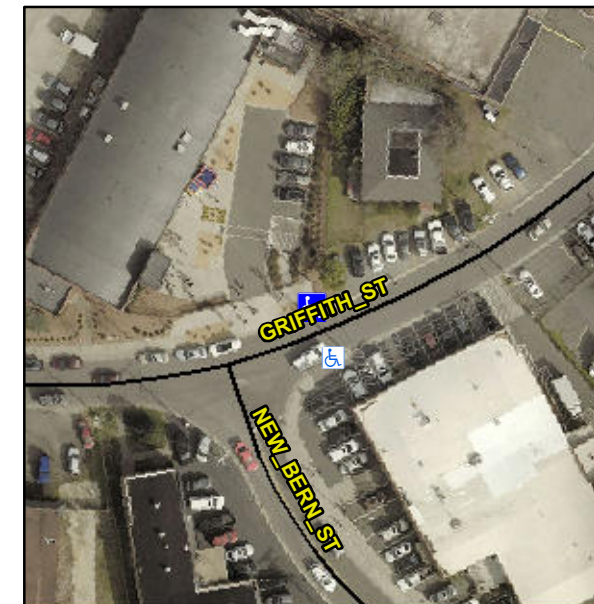
R304.5.1, R304.2.2

Compliance	Description	Data	Compliance	Description	Data
N/A	Ramp Length (in)	86.0	No	Ramp Slope (%)	9.5
No	Ramp Width (in)	47.0	Yes	Ramp XSlope (%)	2.1
N/A	Flare Type LT	N/A	N/A	Flare Type RT	N/A
N/A	Flare Slope LT (%)	N/A	N/A	Flare Slope RT (%)	N/A
N/A	Flare Traversable LT?	N/A	N/A	Flare Traversable RT?	N/A
N/A	Landing Length (in)	N/A	N/A	DWS Provided?	N/A
N/A	Landing Width (in)	N/A	N/A	DWS Contrast?	N/A
N/A	Landing Slope (%)	N/A	N/A	DWS Length (in)	N/A
N/A	Landing X Slope (%)	N/A	N/A	DWS Full Width?	N/A
N/A	Landing Curb? (Y/N)	N/A	N/A	DWS Offset (in)	N/A
N/A	Shared Landing?	N/A			
N/A	Gutter Ponding?	N/A	N/A	Gutter Slope (%)	N/A
N/A	Gutter Lip Ht (in)	N/A	N/A	Gutter X Slope (%)	N/A
N/A	Painted X Walk1?	No	N/A	Painted X Walk2?	N/A
	X Walk 1 Direction	To SE		X Walk 2 Direction	N/A
N/A	X Walk 1 Width (in)	N/A	N/A	X Walk 2 Width (in)	N/A
	X Walk 1 Slope (%)	1.8		X Walk 2 Slope (%)	N/A
	X Walk 1 X Slope (%)	2.8		X Walk 2 X Slope (%)	N/A

N/A	Ramp inside XWalk1?	N/A	N/A	Ramp inside XWalk2?	N/A
	Road Slope (%)	N/A	N/A	Clear Space?	N/A
	Road X Slope (%)	N/A	N/A	Clear Space to XWalk (in)	N/A
N/A	Any Obstructions?	N/A	N/A	Storm Grate/Utility Hazard?	N/A
	Obstruction Type			Storm Grate/Utility Type	
		N/A			N/A
			Yes	Surface Condition? (G/P)	Good

Remove & Replace Entire Ramp.
