Access Compliance Report

Public Rights-of-Way

(Curb Ramps)

| Intersection ID: 48959 | Main Street: FRANKLIN_SQUARE_RD | Cross Street: PERRY_JUNE_AV | Location: SW |

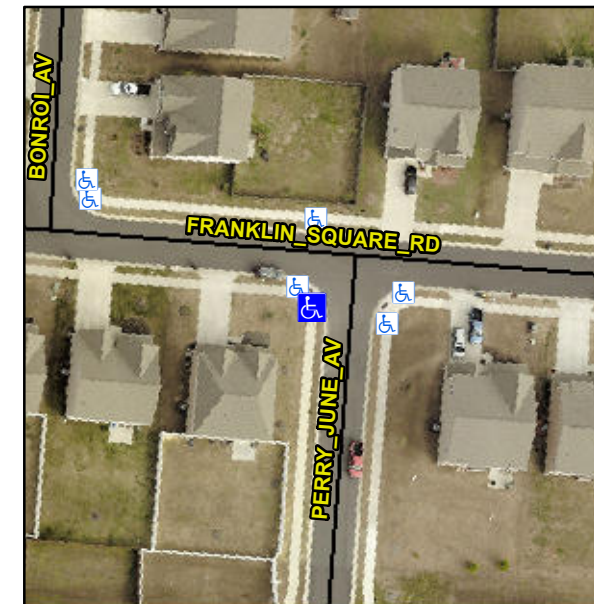
| ADA ID: 51E66AB711E7 | Ramp Type: Perp | Initial Pass/Fail: Fail | Overall Compliance: No |
| Severity Score: 13.75 | | | |

Not Found, R304.2.2, R304.5.3

| Compliance | Description | Data | Compliance | Description | Data |
|---|---|---|---|---|---|
| N/A | Ramp Length (in) | 48.5 | No | Ramp Slope (%) | 11.2 |
| Yes | Ramp Width (in) | 48.0 | No | Ramp XSlope (%) | 3.2 |

Remove & Replace Entire Ramp.

Total Cost: \$ 1850.00
