# Access Compliance Report

## Public Rights-of-Way

### (Curb Ramps)

Intersection ID: 9091	Main Street: GRANT_ST	Cross Street: GRANT_ST	Location:	N
ADA ID: 51E6F9574B1E	Ramp Type: Perp	Initial Pass/Fail: Fail	Overall Compliance: No	Severity Score: 12.5
Codes/Mitigation Info/Possible Solution		Field Measurements/Component Compliance

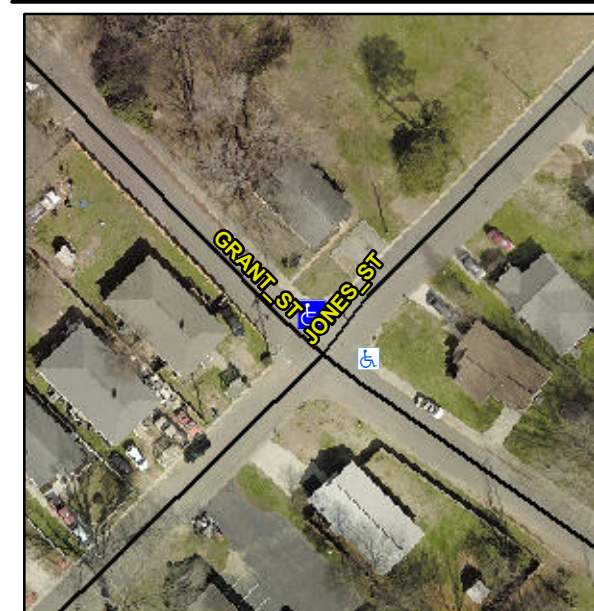
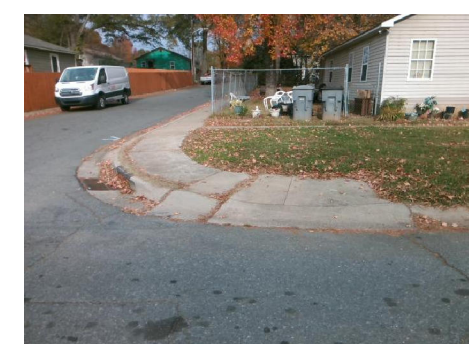
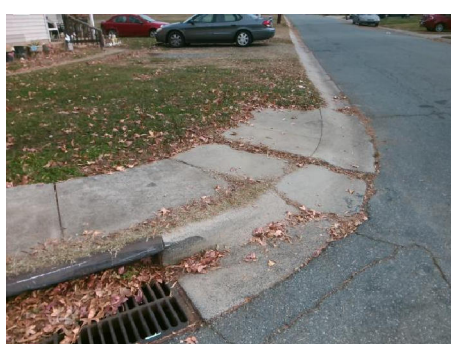
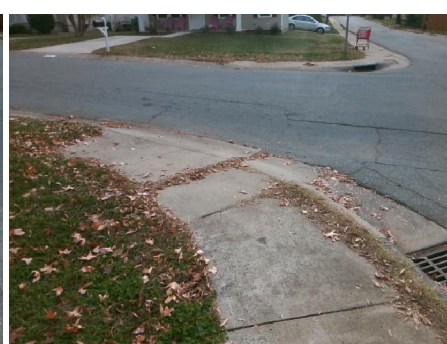
**Not Found, R304.2.2**

Compliance	Description	Data	Compliance	Description	Data
N/A	Ramp Length (in)	46.5	No	Ramp Slope (%)	9.8
Yes	Ramp Width (in)	56.0	Yes	Ramp XSlope (%)	0.2
N/A	Flare Type LT	N/A	N/A	Flare Type RT	N/A
N/A	Flare Slope LT (%)	N/A	N/A	Flare Slope RT (%)	N/A
N/A	Flare Traversable LT?	N/A	N/A	Flare Traversable RT?	N/A
N/A	Landing Length (in)	N/A	N/A	DWS Provided?	N/A
N/A	Landing Width (in)	N/A	N/A	DWS Contrast?	N/A
N/A	Landing Slope (%)	N/A	N/A	DWS Length (in)	N/A
N/A	Landing X Slope (%)	N/A	N/A	DWS Full Width?	N/A
N/A	Landing Curb? (Y/N)	N/A	N/A	DWS Offset (in)	N/A
N/A	Shared Landing?	N/A			
N/A	Gutter Ponding?	N/A	N/A	Gutter Slope (%)	N/A
N/A	Gutter Lip Ht (in)	N/A	N/A	Gutter X Slope (%)	N/A
N/A	Painted X Walk1?	No	N/A	Painted X Walk2?	N/A
	X Walk 1 Direction	To SE		X Walk 2 Direction	N/A
N/A	X Walk 1 Width (in)	N/A	N/A	X Walk 2 Width (in)	N/A
	X Walk 1 Slope (%)	3.5		X Walk 2 Slope (%)	N/A
	X Walk 1 X Slope (%)	2.5		X Walk 2 X Slope (%)	N/A

N/A	Ramp inside XWalk1?	N/A	N/A	Ramp inside XWalk2?	N/A
	Road Slope (%)	N/A	N/A	Clear Space?	N/A
	Road X Slope (%)	N/A	N/A	Clear Space to XWalk (in)	N/A
N/A	Any Obstructions?	N/A	N/A	Storm Grate/Utility Hazard?	N/A
	Obstruction Type			Storm Grate/Utility Type	
		N/A			N/A
			Yes	Surface Condition? (G/P)	Good

**Remove & Replace Entire Ramp.**

Total Cost: \$ 1850.00
