Access Compliance Report Public Rights-of-Way (Curb Ramps)

Intersection ID: 28218 Main Street: FORTBRIDGE_LN Cross Street: HIGHGROVE_ST Location: NE

ADA ID: 51EA79BF777C Ramp Type: PerpDiag Initial Pass/Fail: Fail Overall Compliance: No Severity Score: 13.75

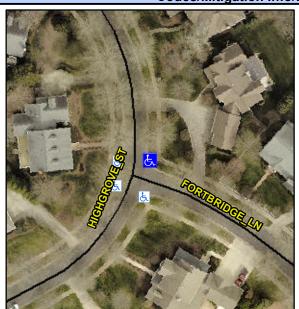
Compliance Description Data Compliance Description Data No N/A Ramp Length (in) 102.0 Ramp Slope (%) 8.5 No Yes Ramp Width (in) 54.0 Ramp XSlope (%) 3.8 N/A N/A Flare Type LT N/A Flare Type RT N/A N/A N/A Flare Slope RT (%) N/A Flare Slope LT (%) N/A N/A Flare Traversable LT? N/A N/A Flare Traversable RT? N/A N/A N/A N/A **DWS Provided?** N/A Landing Length (in) N/A Landing Width (in) N/A N/A **DWS Contrast?** N/A N/A N/A Landing Slope (%) N/A DWS Length (in) N/A N/A Landing X Slope (%) N/A N/A DWS Full Width? N/A N/A Landing Curb? (Y/N) N/A N/A DWS Offset (in) N/A N/A N/A Shared Landing? N/A **Gutter Ponding?** N/A N/A Gutter Slope (%) N/A N/A Gutter Lip Ht (in) N/A N/A Gutter X Slope (%) N/A N/A Painted X Walk1? No N/A Painted X Walk2? No X Walk 1 Direction To NW X Walk 2 Direction To SW N/A N/A X Walk 1 Width (in) X Walk 2 Width (in) N/A X Walk 1 Slope (%) 3.0 X Walk 2 Slope (%) 2.9 X Walk 2 X Slope (%) X Walk 1 X Slope (%) 1.3 3.2 N/A N/A N/A Ramp inside XWalk2? N/A Ramp inside XWalk1? Road Slope (%) 1.5 N/A Clear Space? N/A N/A Road X Slope (%) Clear Space to XWalk (in) N/A 4.8 N/A N/A Any Obstructions? N/A Storm Grate/Utility Hazard? N/A Obstruction Type Storm Grate/Utility Type N/A N/A

Remove & Replace Curb Ramp With Two New Directional Ramps or Equivalent.
